Retaining Structure to Pilgrims Way East Otford, Kent.

Structural Inspection Report

Reference: 23-0522

Revision: A

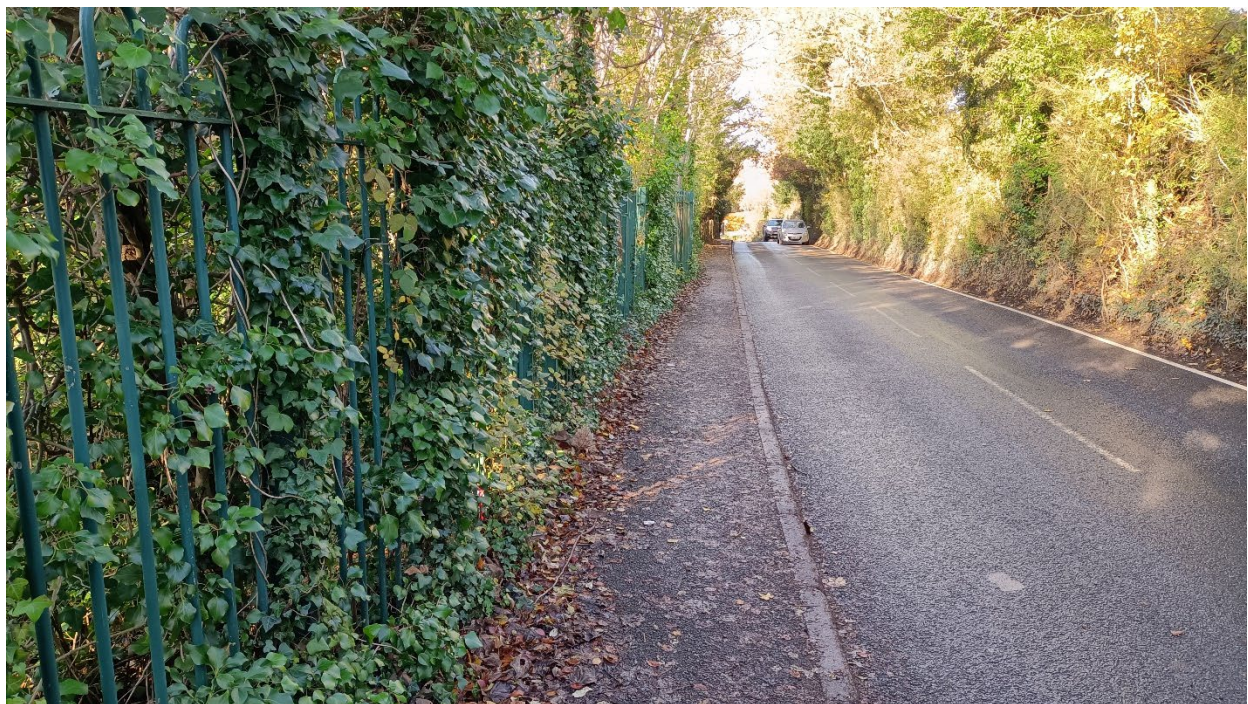
Along the top of the chalk face the footpath, kerb line and carriageway showed no signs of wall or embankment failure, being in a good condition (see photos 2 & 3). It should be noted that, we do not know if the road has been resurfaced since the works to the chalk face were carried out.

Photo 2 – Looking west along Pilgrims Way East.

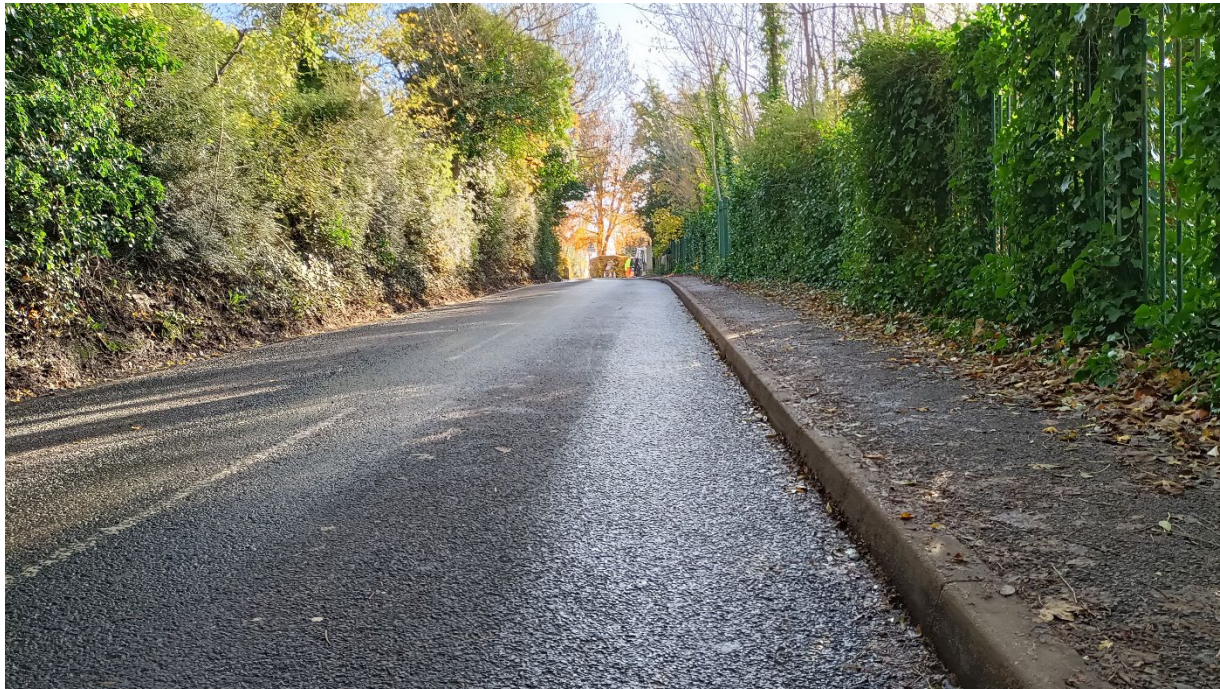
Photo 3 – Looking East along Pilgrims Way East.

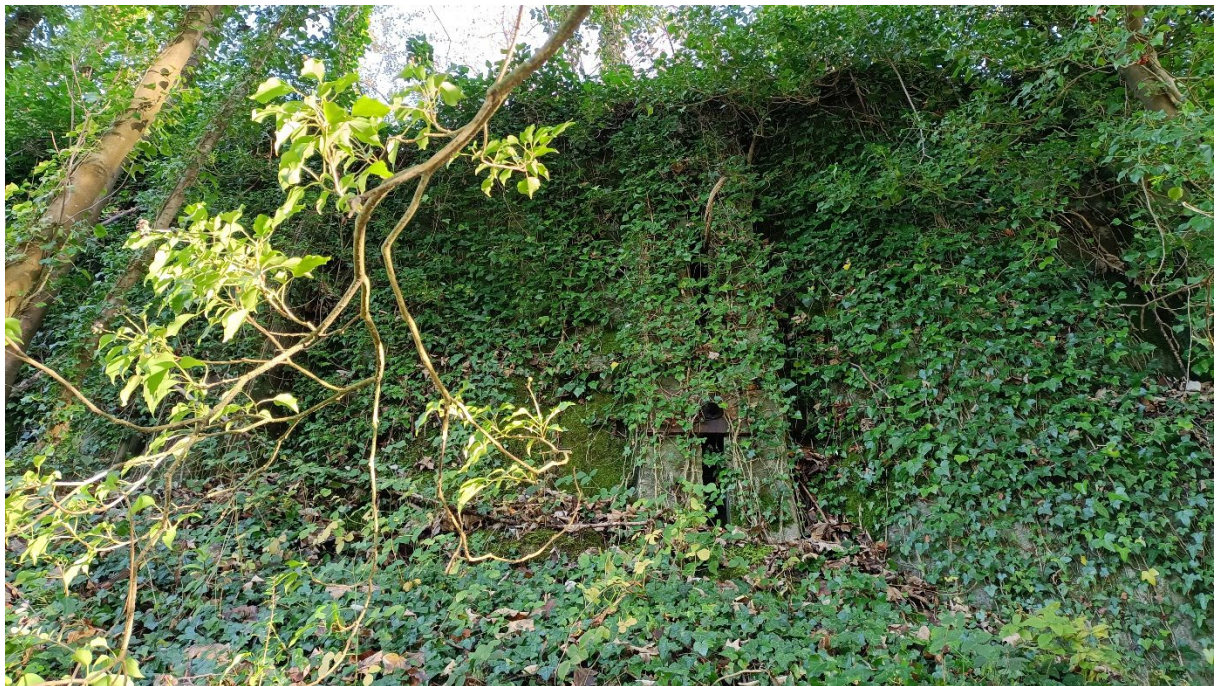
The existing chalk pit sides have been reinforced with concrete piles which appear to be in pairs which have then been tied back using rock anchors top and bottom.

Photo 4 – Concrete piles with ties visible.

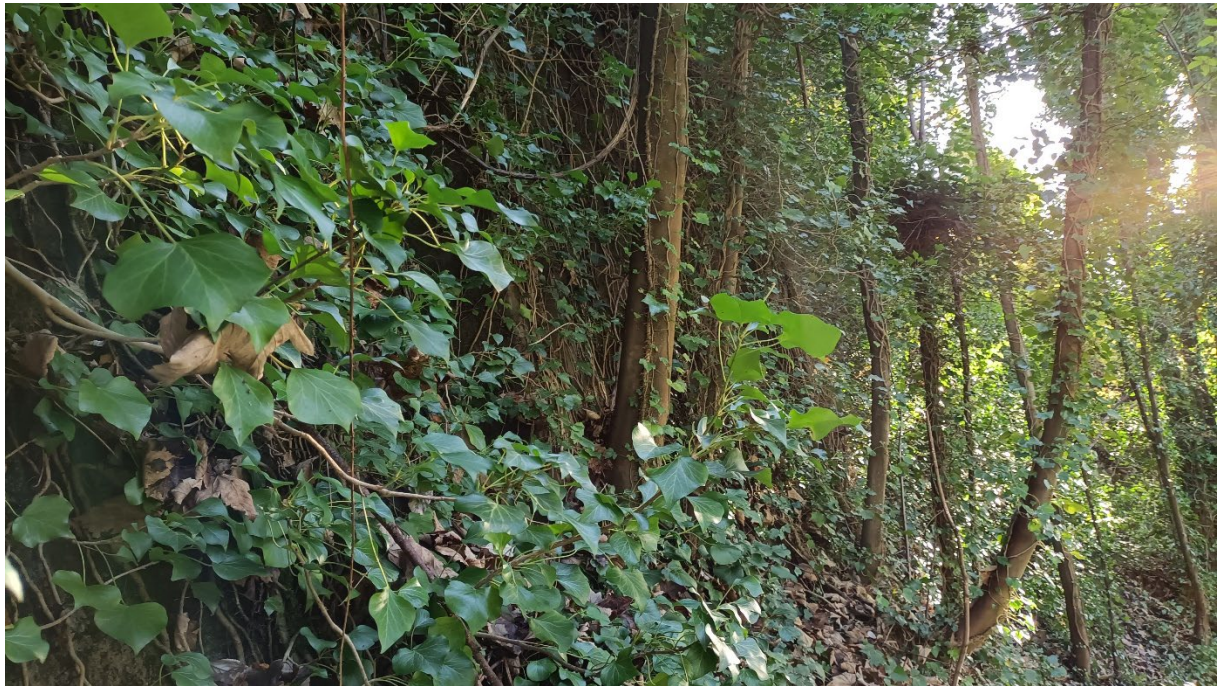
What could be seen of the piles and embankment from the lower levels, was that the area was heavily covered in vegetation and that the trees that were growing were generally vertical and hence not showing signs of any ground movement.

Photo 5 – Vegetation growing on embankment.

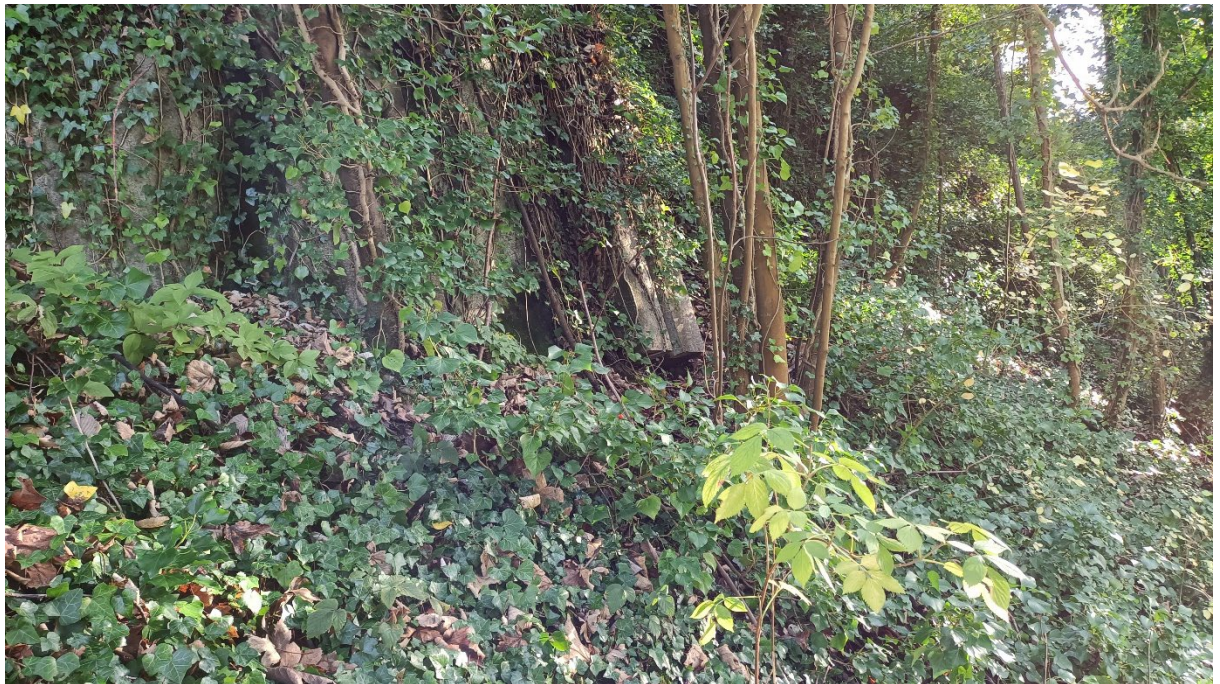
Photo 6 – Concrete piles to wall.
