# BRADBOURNE LAKES, SEVENOAKS, KENT Conservation Management Plan

Client: Sevenoaks District Council November 2025

Zenith Built Heritage and Collington Winter Environmental

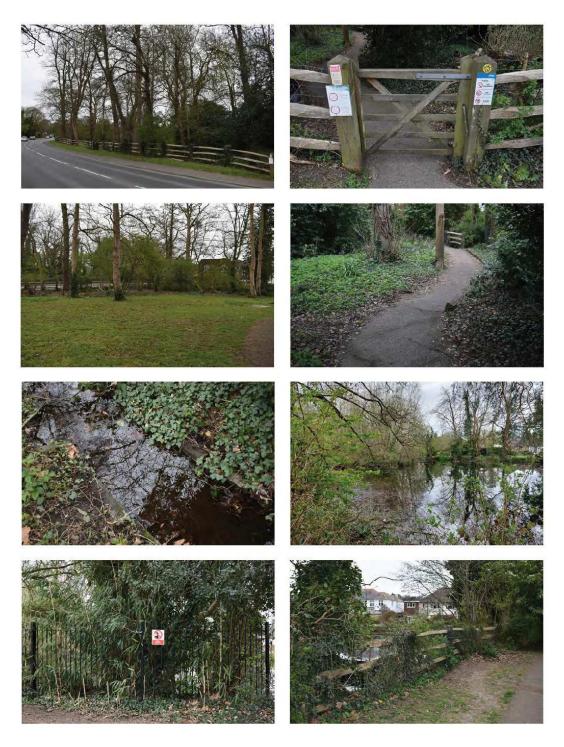
Plate 1: Images of Character Area 1

The lake has an irregular shape and is the most natural in character of all the Bradbourne Lakes, largely defined on all sides by vegetation, some mature (Plate 1.6). The lake edge appears to be of a ragstone construction in places, however access to the full extent of the lake was not possible at the time of survey and where the ragstone is visible, it appears to be in poor condition. Water flows into the lake via the shallow stream to the south and outfalls to the north. The north eastern corner of the character lake edge is fenced with a combination of tall iron railings, painted black and a wooden cleft fence (Plates 1.7 and 1.8). Large swathes of bamboo are present to the lake edge, especially to the north east, which largely restricts visual access across the water and in some places, is encroaching upon the mature bank side trees.

Areas of marginal vegetation appear frequently to the lakes edges and were noted to provide both habitat and foraging opportunities for the abundant waterfowl which appear in the park. At the time of site assessment, the water level in the lake appeared to be low and it was noted that leaf litter covered many of the marginal edges and exposed areas of silt, creating rafts which were also utilized by the waterfowl for resting and nesting.

There is a small island standing to the south of the lake, which appears to be heavily colonised by young, coppiced trees and shrubs, with abundant emergent aquatic vegetation to the edges. There was no access to the island at the time of site assessment, however it appeared to be utilised by a variety of nesting waterfowl.

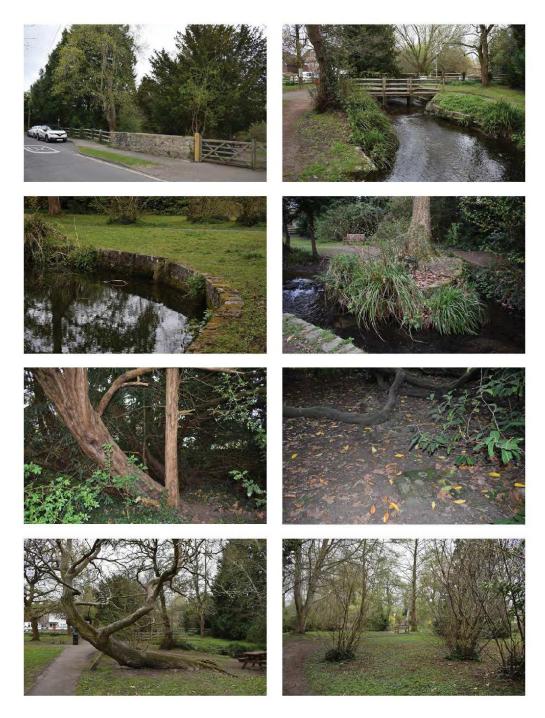
Plate 3: Images of Character Areas 3 and 4

The shallow stream emerges from beneath Betenson Avenue within two box culverts and runs in a narrow channel towards Lake 5. A narrow pedestrian bridge, with wooden pail fencing crosses the narrow stream and allows access into the south western corner, beneath the canopy of the mature trees (Plate 3.2). The channel is retained by a ragstone wall (Plate 3.3); however, this has failed in several locations and there are clear desire lines leading into the water. A set of stone steps on the eastern bank also allow access into the stream. At locations where the retaining wall has failed, marginal vegetation is colonising the bare ground.

The boundary to the east is defined by a tall wooden close board fence, with a significant area of bamboo and hazel coppice creating an enclosed vegetated area (Plate 3.2). A single oak stands within close mown grass to the south eastern corner, and a ginkgo stands adjacent to the gateway. A mature Holm oak was noted standing in open grassland to the north of the character area.

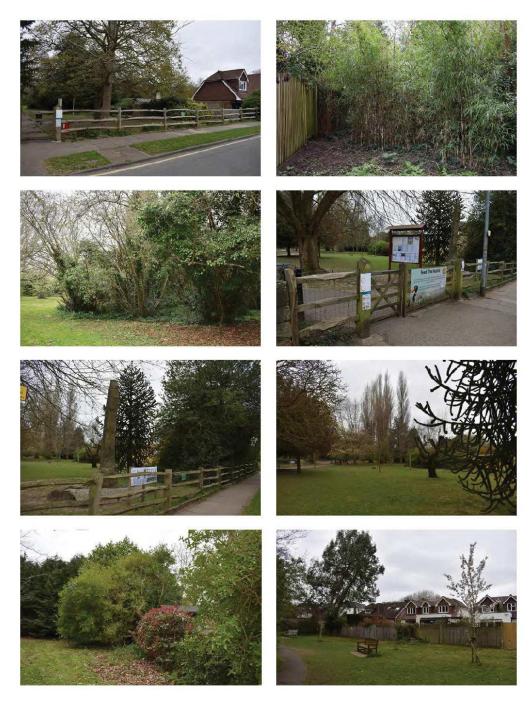
Plate 4: Images of Character Areas 5 -6

This character area is perhaps the most popular and has a high value in terms of visitor use. Numerous park users were observed in this space during the site assessment. This character area is also where a large number of waterfowl congregate, close to the lakes and to the visitor feeding station on the adjacent Ornamental Lake. Such high numbers of waterfowl do however have an impact upon the grassland, which is showing signs of wear due to the constant grazing pressures placed upon it. Tree roots within this area were also observed to be exposed and vulnerable to damage.

Water enters the Ornamental Lake via an outfall from Lake 3, which is crossed by a narrow pedestrian bridge with a wooden pail upstand (Plate 4.2). The stepped outfall, which appears to be in visually good condition, is an aesthetically pleasant feature, with the sound of fast flowing water adding to the character of the lake.

The eastern side of the Ornamental Lake has no trees, however there is a small shrub. Despite the lack of trees, the lakeside bank has a poor covering of grass, which may be attributed to several factors including poor light levels from adjacent trees and the constant wear from park users and the resident waterfowl.

lakes extend up towards the paths, however most of these grass edges were heavily worn at the time of site assessment, with the sward struggling with low light levels, the high volume of visitor traffic and the high numbers of waterfowl observed within this character area, especially around the popular waterfowl feeding areas. High numbers of waterfowl, combined with visitor traffic is leading to the exposure of roots of the mature broadleaves around the lake (Plate 4.4).

The lake edges have a varying condition, although the overwhelming character where edges have been artificially reinforced, is one of a steady decline in condition. Where trees are growing close to the lake revetments, there is visible damage to structures, with fallen trees and exposed tree roots creating breaches in the walls. Natural lake edges occur around all three of the water bodies and vary in condition according to bank side vegetation. Where vegetation is abundant and restricts access to the water for waterfowl, the edges appear in better condition than those where soil is being eroded away.

There are three small islands in the middle of Lakes 1 and 3, which have abundant overgrown vegetation. The islands are inaccessible to all except the waterfowl and make excellent nesting habitats (Plate 4.7). There is also a small area between Lake 1 and Lake 2, which is fenced to restrict access (Plate 4.8). This area is largely overgrown with scrub and mature trees, predominantly sycamore and alder, however there is a semi-mature yew, which is in good condition and several hawthorns. With retained deadwood and restricted access to park visitors, this small, fenced area is a wildlife haven to the east of the fenced area, and standing on the northern bank of Lake 1, is an impressive mature London plane tree (T283).

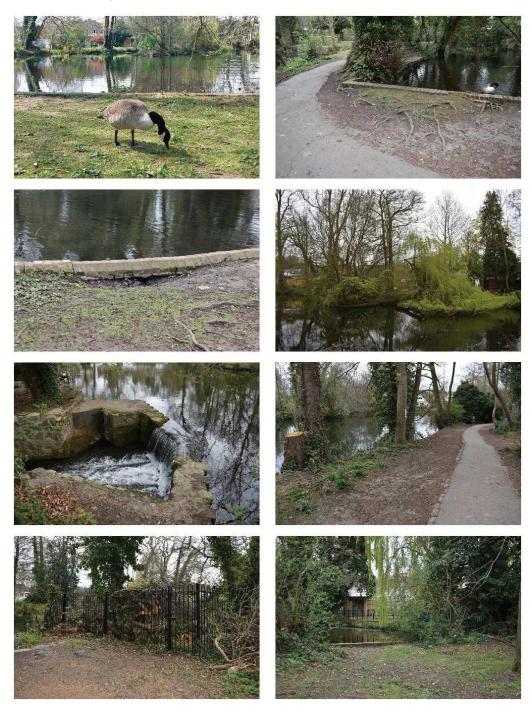
Plate 7: Man-Made Lake Features

The Assessment of Existing Structures and Outline Proposals for Remedial Works noted in 2022 that there is damage to the easternmost island bank "Plastic sheet

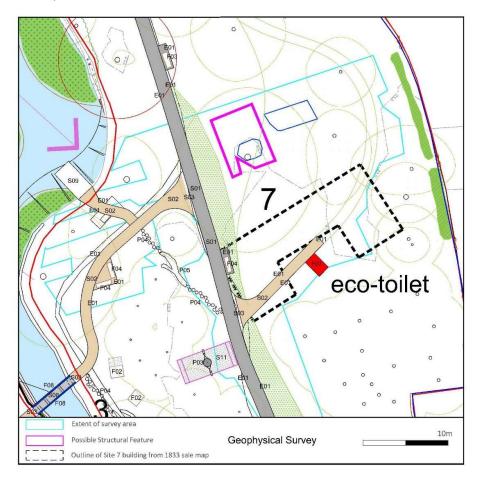
Figure 27: Location of proposed eco-toilet in relation to the GPR anomaly It is therefore recommended that an archaeological watching brief be maintained during the ground works for the toilet.
