## J BUNGALOWS CHARACTER AREAS

# J01 – HOMEFIELD ROAD

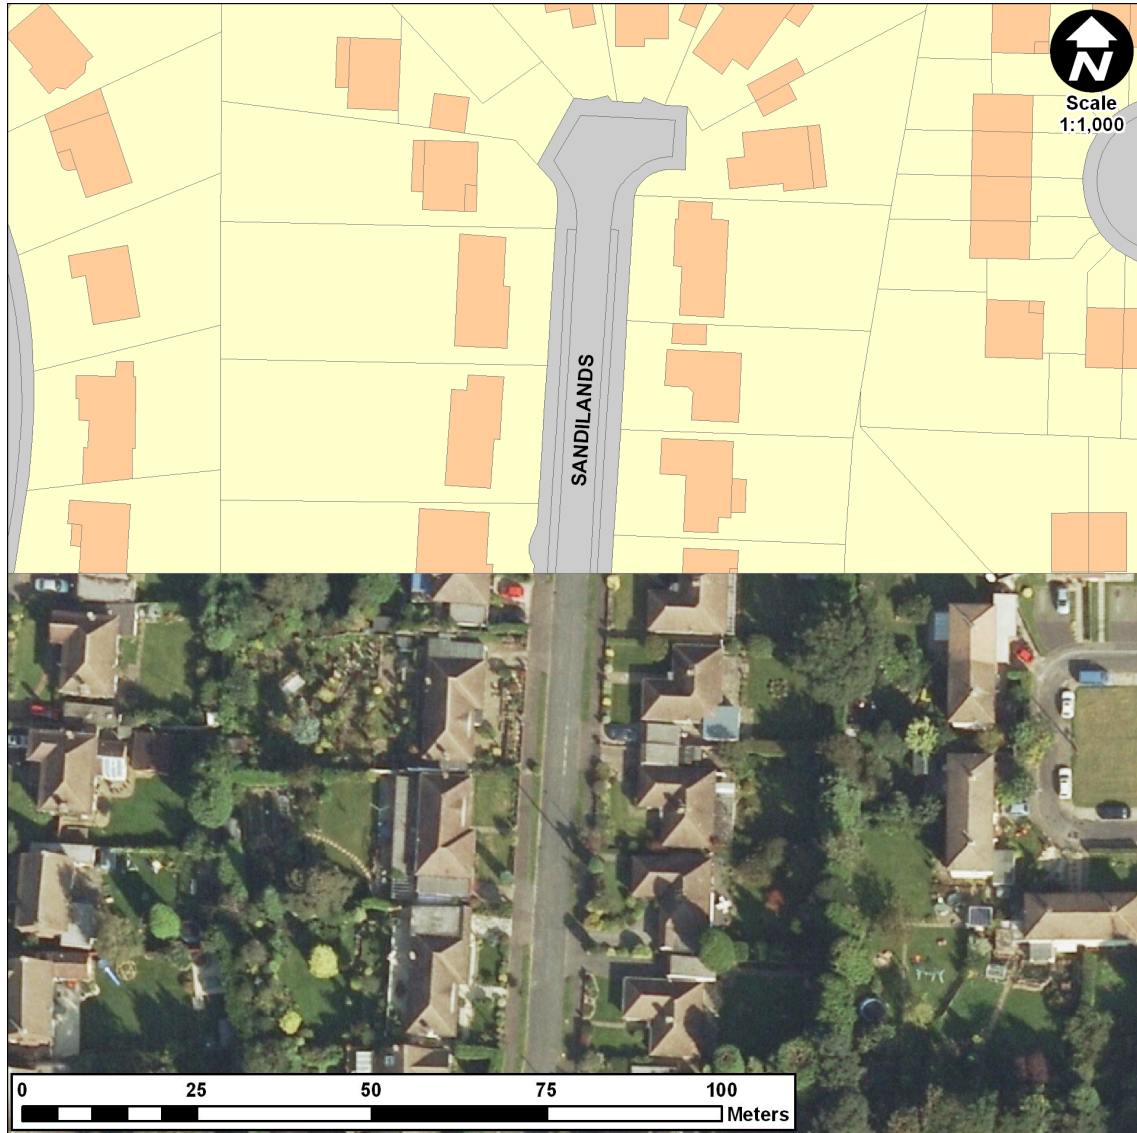
Example of Bungalow Development Layout

The design of the bungalows changed in these two periods with the earlier bungalows generally being squarer and having more elaborate rooflines, hipped roofs, porches and more design detail than the later buildings which tend to be plainer and more rectangular in design with gabled roofs. The bungalows often have front gardens enclosed by low walls and hedges. Despite these differences, where bungalows predominate, even where the building style is different, the character of the area tends to be similar as the single storey buildings create an open, relatively uniform townscape.

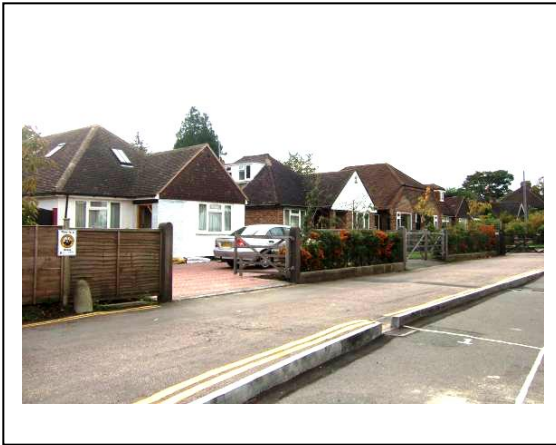
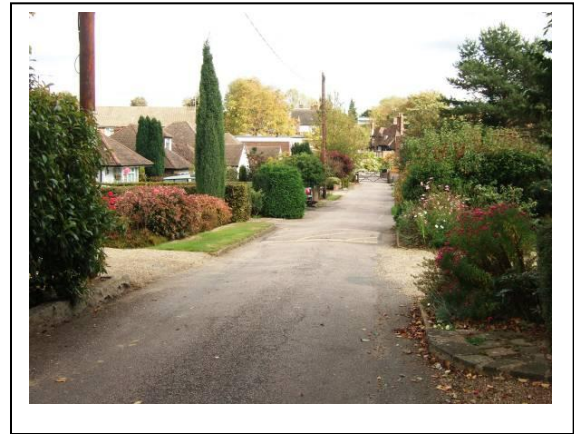
*Homefield Road is a private, gated I-shaped cul-de sac. The eastern end (above left) is more urban in character with a wide pavement and there are flats, parking areas and shops to the north side of the road. The western section (above right), beyond the barrier, is more informally laid out with no pavements, some verges and landscaping in the form of hedges, shrubs and garden trees. This section has a particularly private, quiet residential character despite its proximity to the centre of Riverhead. The land rises gently to the west and there is a vista eastwards into the Riverhead Conservation Area.*

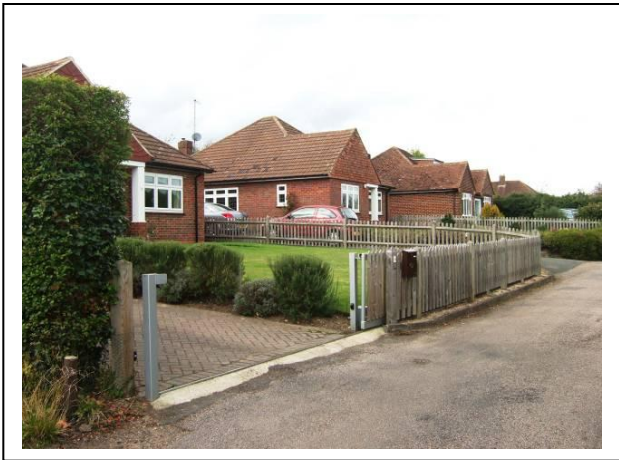
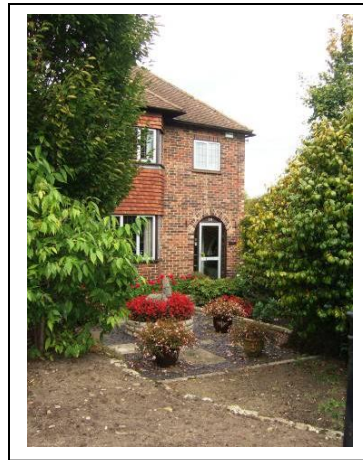
*At the western end of the street, there are several two storey properties (above right) and bungalows on wider plots (above left) in an informal mix of styles.*

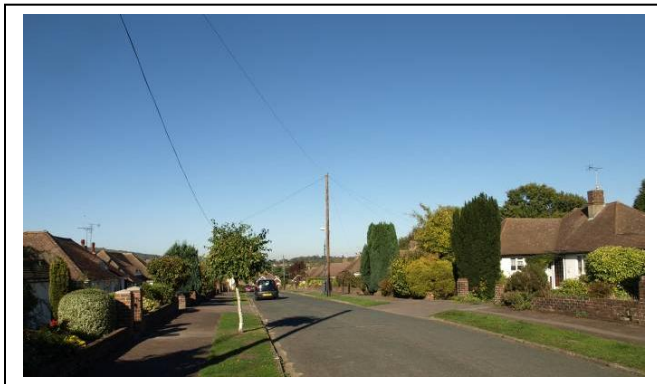
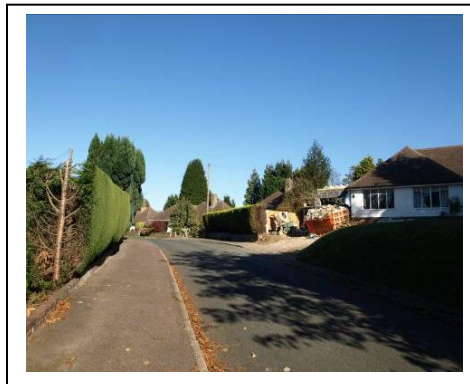
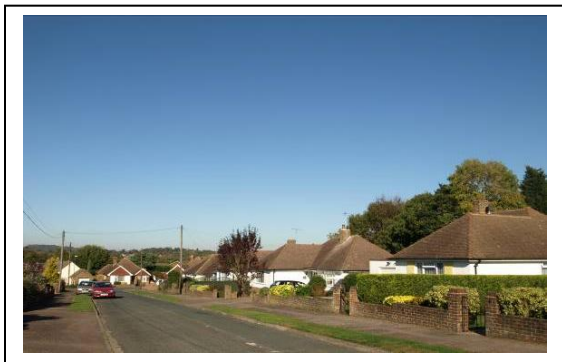
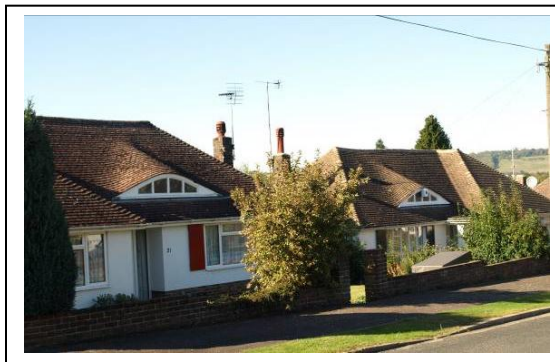
*The bungalows are set back from the wide road and verge on a regular building line with long views to the North Downs resulting in a wide unenclosed space in contrast to the narrow curved entrance (above right). Hipped roofs further reduce the scale of development. The bungalows are laid out in symmetrical pairs in an alternate 'L' shaped plan form. White render and brown roof tiles are repeatedly used materials. Eye brow windows create a variation within some of the roofs (bottom right). The regular building line, uniform scale,*

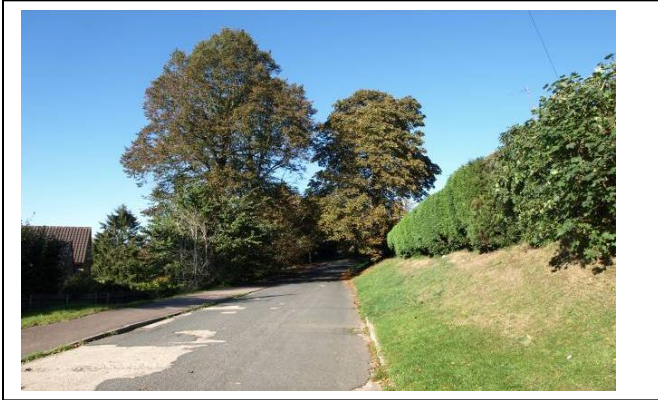
*The narrow, curved, enclosed entrance to Sandilands has a verdant quality with grass verge, hedgerow and trees which conceal all development from Chipstead Road.*

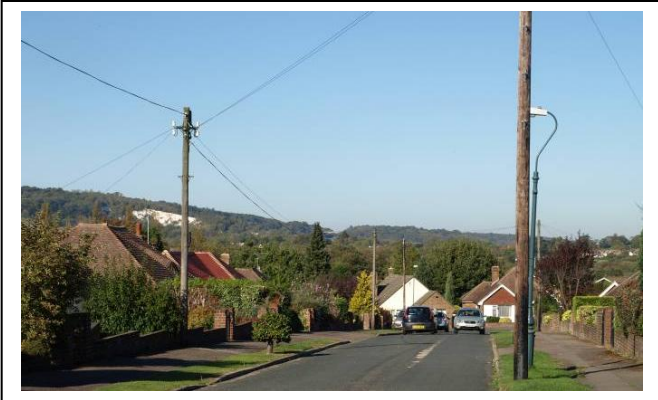
## Views

*The panoramic views of the North Downs are visible above and between the roofs.*

Views of the North Downs

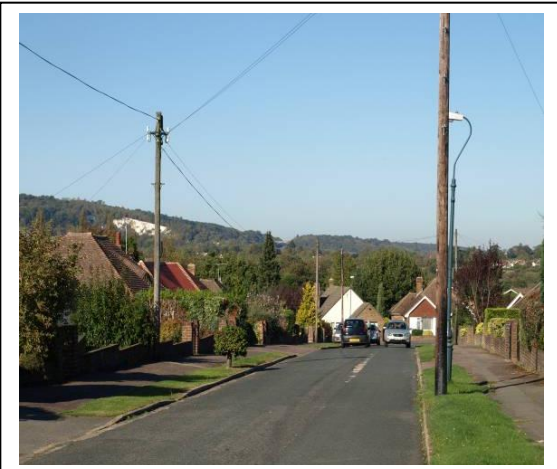
*Telegraph poles and overhead wires become prominent within such a low scale development (left).*

Prominent telegraph poles and overhead wires

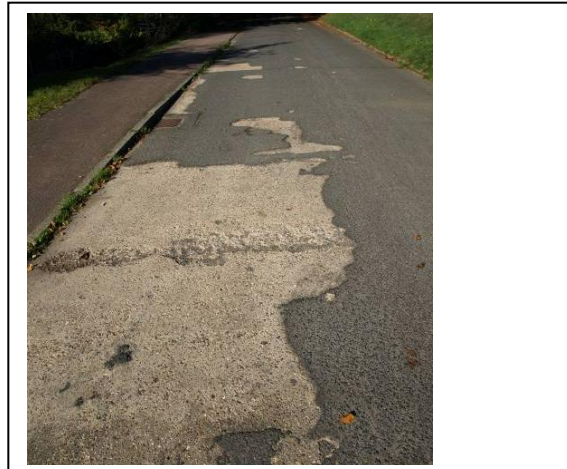
*The road surface of Sandilands is in poor condition (right).*

The road surface of Sandilands is in poor condition

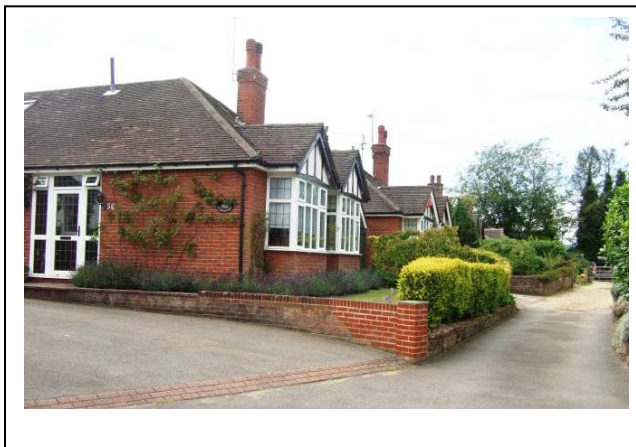
*The four bungalows are set on an even building line behind landscaped front gardens enclosed by dwarf walls and hedges, facing onto a shared access. They are of red brick with hipped roofs and half timbered gables above square bay windows with prominent tall brick chimneys located between the bays. They have small pitched dormer windows.*

*The bungalows form a cohesive and distinctive group.*

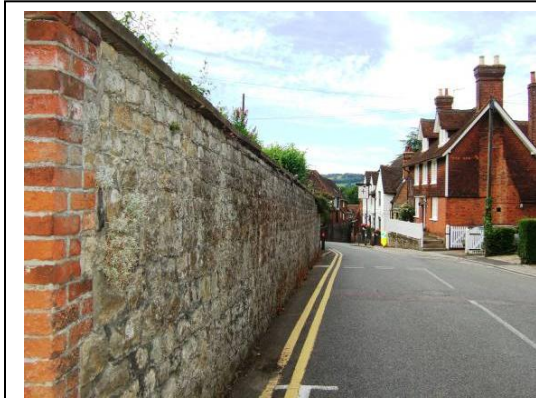
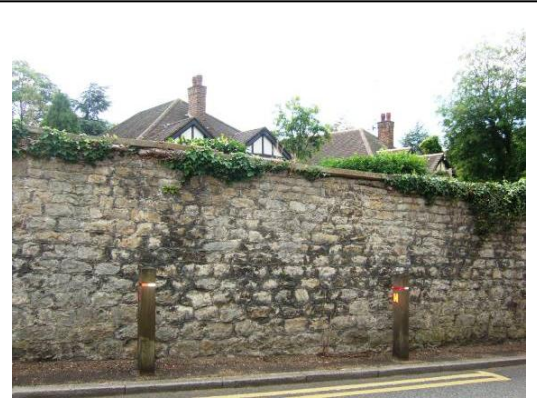
*The bungalows are on an elevated site on the south side of the High Street in a sensitive position immediately adjoining the Chipstead Conservation Area to the east and north. They are set behind a tall old ragstone wall with only the rooftops and chimneys visible from the road (above right).*

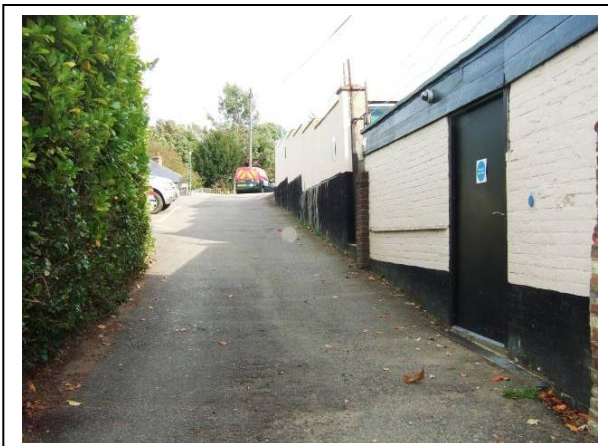
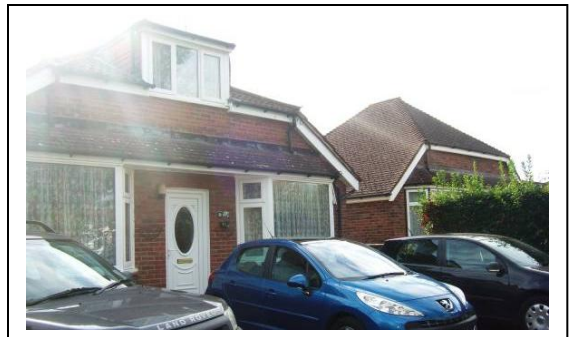
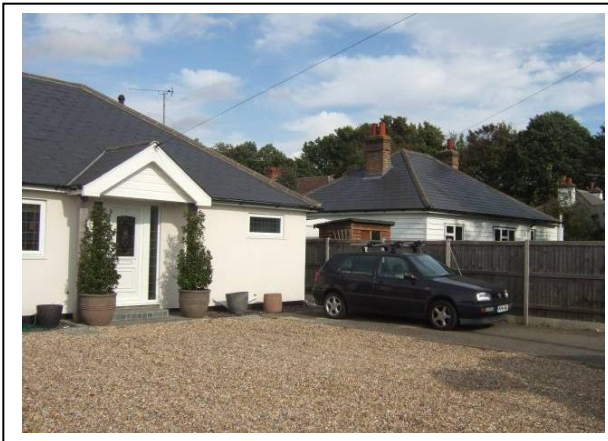
*The Patch is accessed via a narrow entrance enclosed by buildings and a hedge. The entrance also provides access to an informal parking area and commercial units. The bungalows are set back on a regular building line behind hard surfacing or landscaped gardens partially enclosed by fences and hedges. Those to the north are white weatherboard with slate roofs, those to the south are red brick with tiled roofs. The properties have been altered and modernised. The tree belt along the railway line closes the view to the east and is visible over the houses. The area has an informal, mixed use character. The surfacing is poor and there is noise from the London Road and the railway.*

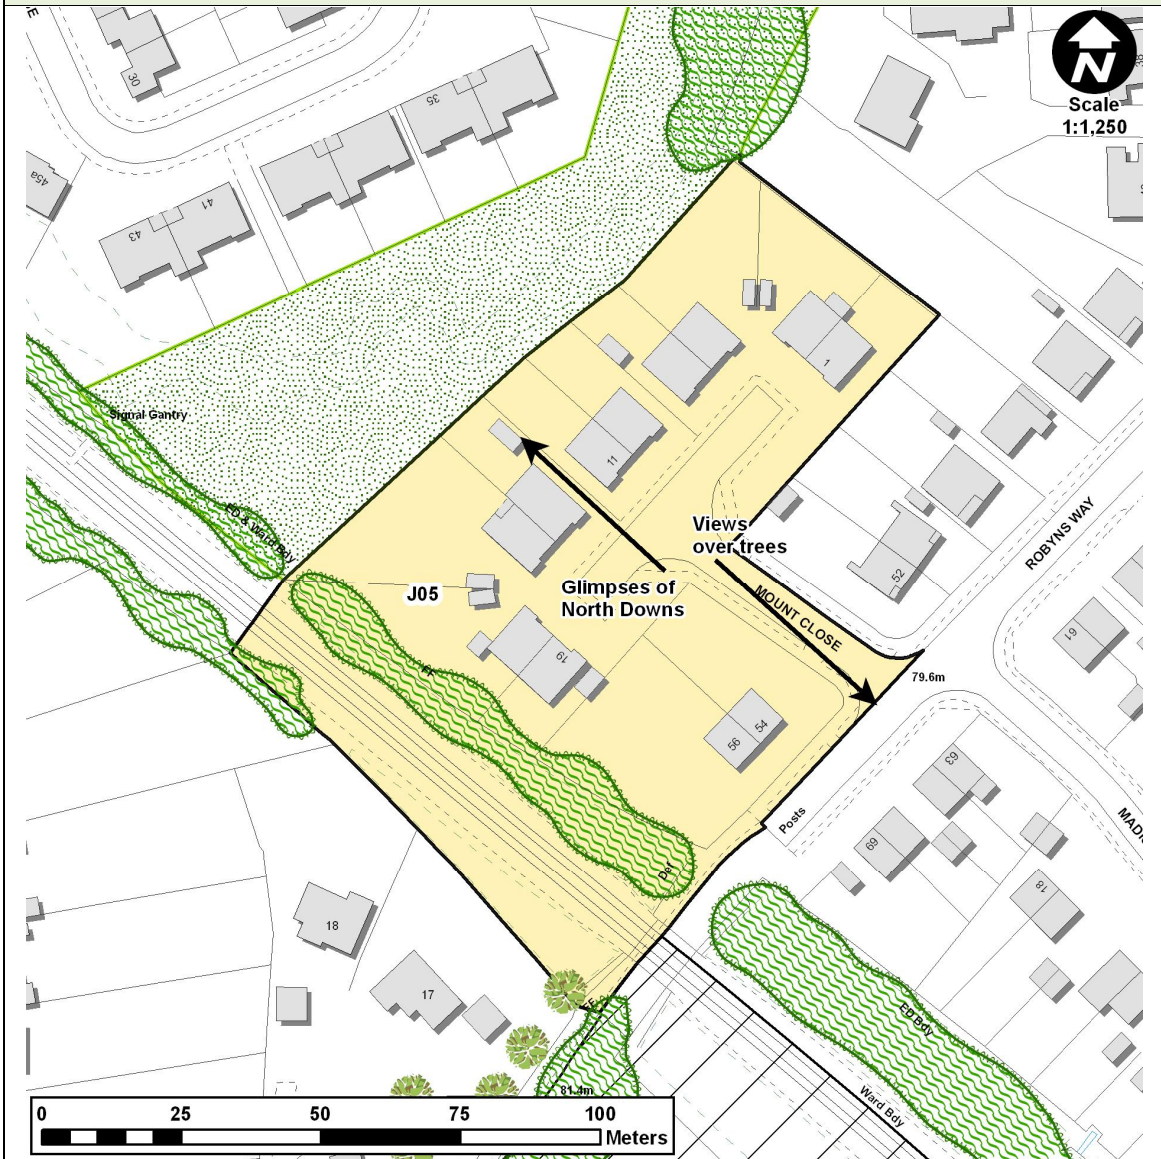
## TOWNSCAPE MAP

Locally Distinctive Contextual Features	
Age of buildings	Early 1960's
Type of buildings	Detached
Main uses	Residential
Building heights	One storey
Prominent building materials	Buff brick, pale paint, brown roof tiles.
Predominant boundary treatments	Open plan
Open space/ vegetation	Tree belt to the west. Views over trees to the south.

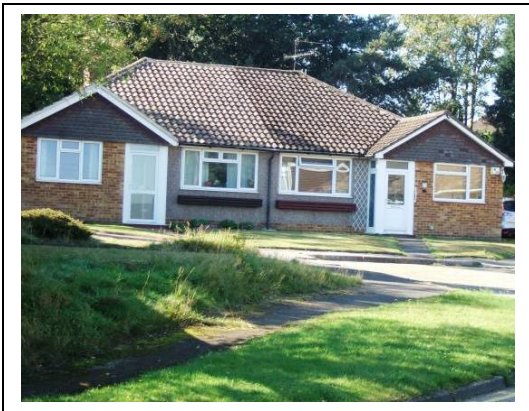
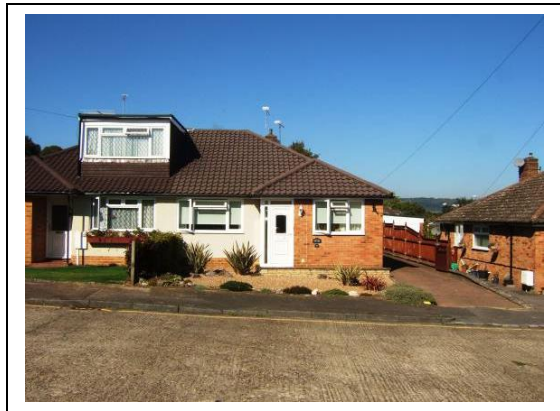
*Mount Close is a short cul-de-sac leading up steeply from Robyns Way. Five pairs of symmetrically designed semi detached bungalows are arranged on a regular building line set back behind unenclosed front gardens around the top of the turning head. The buildings are of buff brick with painted sections, wide white framed windows and brown tiled hipped roofs some with shallow front facing gables. A prominent dormer extension affects the symmetry and roofline. There are glimpses between the houses of the North Downs to the north (above right). A tree belt runs along the railway line to the west.*

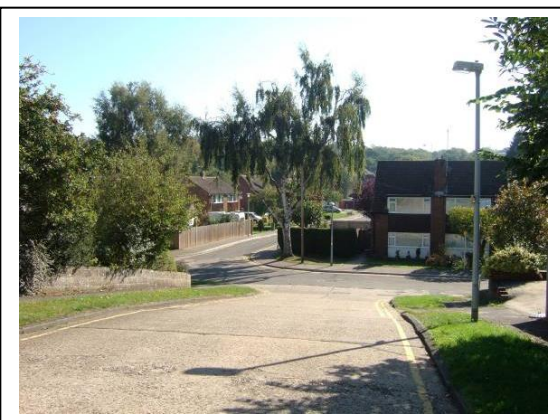
*The access road is lined by verges. There are views to the south over rooftops and trees. The concrete road surface is in moderate condition.*

Concrete road surface in moderate condition  
Prominent dormer disrupts the roofline and symmetry of the Close

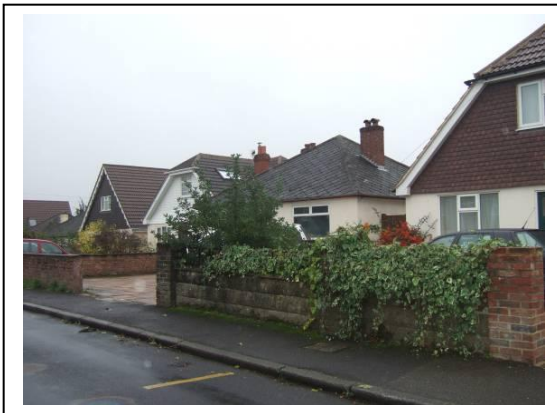
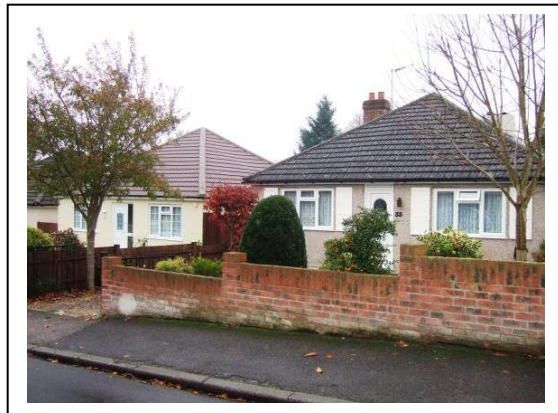
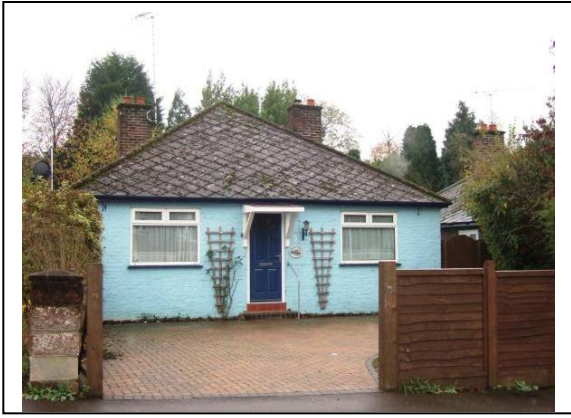
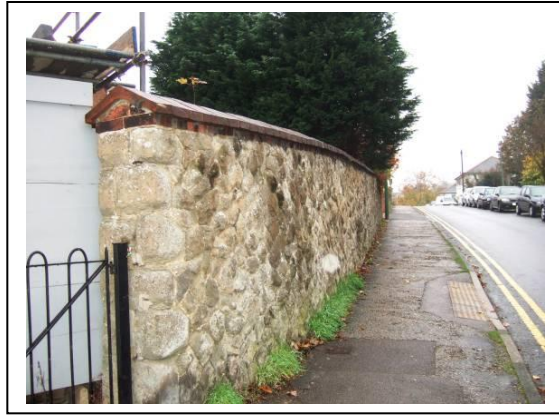
*The bungalows are set back on a relatively regular building line behind landscaped front gardens enclosed by brick walls, panel fences and hedges (above). Some have retained their original appearance with a square footprint, a central front door flanked by wide windows, pyramid shaped hipped roof and small chimneys on the side pitch. Many of the properties have been converted to chalet bungalows with replacement roof tiles creating a varied, but still low, roofline with gable ends facing the road with a variety of decorative finishes. The majority of the houses are painted in pastel shades. The Old Hillingdon Lodge marking the historic entrance to the Wildernesse Estate is partially demolished but the ragstone wall leading into Hospital Road is a feature (below right). Trees close the view to the east and the area overlooks remnant woodland to the north.*

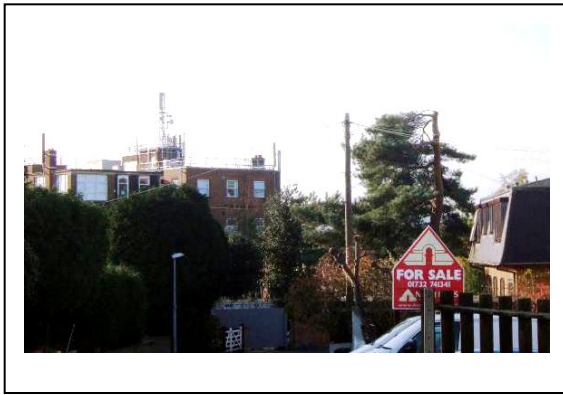
*The view of the hospital roof to the west is a detractor.*

View of hospital roof to the west  
Poor surfacing
