# BRADBOURNE LAKES, SEVENOAKS, KENT Conservation Management Plan

Client: Sevenoaks District Council November 2025

Zenith Built Heritage and Collington Winter Environmental

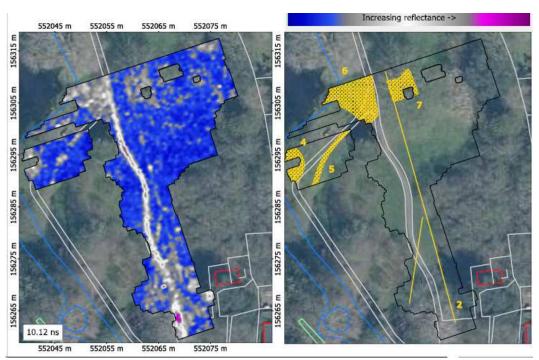
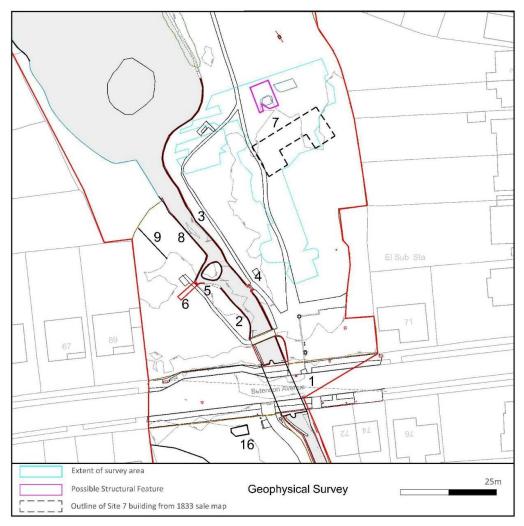
A geophysical (GPR) survey was undertaken by Tigergeo (2025) which was intended to determine if there is any below ground survival of the building and if so to clarify where it is and if there will be any conflict with proposed landscape designs. The survey did identify a rectangular feature that was c 7m x 5m in size, which is about 5m to the north west of the predicted location of the building based on the 1833 map (Figure 24). The geophysical survey report (*ibid*) suggests that this anomaly "could have a structural origin, e.g. a buried floor surface" but also raises the caveat that this is only a tentative interpretation. The anomaly is approximately orientated with the documented feature, and is in the right approximate location, but is smaller than that shown on the 1833 map where each wing was depicted as being orientated north west/ south east and c 10m x 6m (Figure 25). While the anomaly is evidently smaller than the depiction on the map, that could be down to draughting discrepancies on the pre ordnance survey mapping. Although there is some correlation in terms of

orientation, location and approximate size, this could only correspond to one of the wings and there are no indications of the other wing or the linking structure.

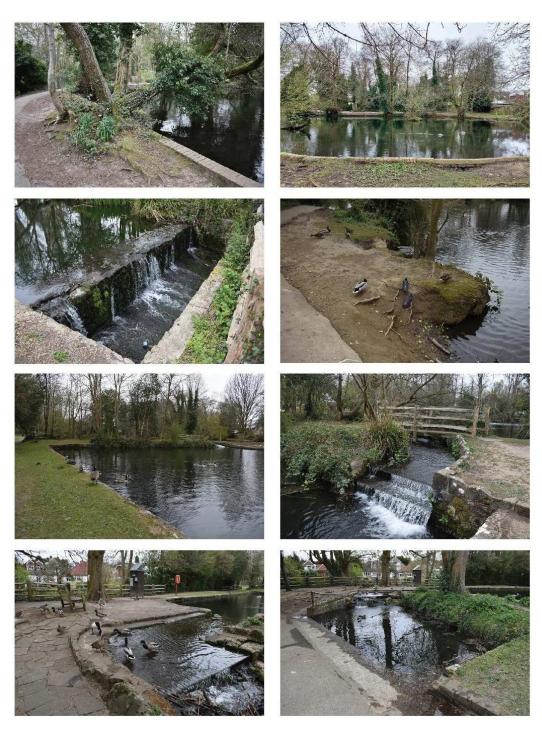
Plate 8: Man-Made Lake Features

The edges of Lake 3 appear to be retained predominantly by a ragstone wall with brick copings (Plate 8.2), which is in visually reasonable condition however the Assessment of Existing Structures and Outline Proposals for Remedial Works report notes that at the eastern edges "Historic remedial repairs appear to have been made to the base of this section of wall using permanent corrugated plastic formwork...". There are, however, sections where the coping has been undermined.

The number of inlets and outfalls creates visual and auditory interest for park users, where water is flowing into and out of the Lake. The outfall into the stream is visible at close quarters and provides a dramatic feature, with water tumbling over the stone weir and down through a culvert beneath the path into the canalised stream (Plate 8.3). These structures were noted to be in good condition in the Assessment of Existing Structures and Outline Proposals for Remedial Works report, however there is concern that the ragstone walls are undermined in several locations "due to scouring of bed joints by fast flowing cascade (at the inlet from Lake 2)" and "Local undermining has resulted in voids at the base of the ragstone retaining wall (south eastern edge)". The report also notes that "Large trees have grown to surround the original masonry retaining wall. This has led to damage of the walls through the ingress of roots and root heave (western edge)".

Where the edges are naturalised, erosion has occurred, such as at the south western edge adjacent to Lake 2 (Plate 8.4), however at the northern edge, adjacent to Lake 4, the naturalised edge appears stronger and intact. The erosion of the naturalised edges may be largely caused by the prevalent waterfowl, especially where the key feeding areas are located.

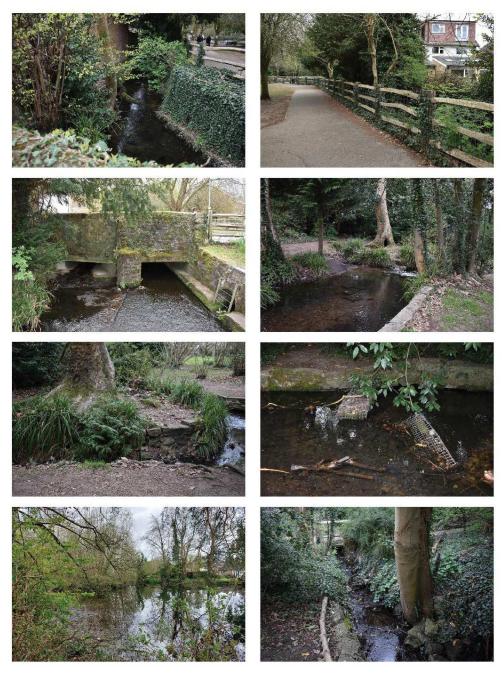
Plate 9: Man-made lakes and water features

Shallow Stream - The canalised Stream flowing from the South Park and through the culvert beneath Betenson Avenue emerges into a Shallow Stream to the south of the North Park (Plate 9.3). This Shallow Stream is formed by low level ragstone walls of variable condition. There are visible areas where the wall is deteriorating and visible areas where it has been completely destroyed, presumably through historic vegetation ingress and the movement of park users wishing to gain access into the water (Plate 9.4).

A number of mature trees grow adjacent to the stream, many with roots ingressing into the stonework. A key feature of the stream is a small central island, located mid way between the Betenson Avenue Bridge and Lake 5. The island, which stands proud above the water level and is retained by a ragstone wall, contains a single mature London plane tree, which may pre-date the island (Plate 9.5). The ragstone revetment is damaged, presumably be the scouring action of water and root ingress.

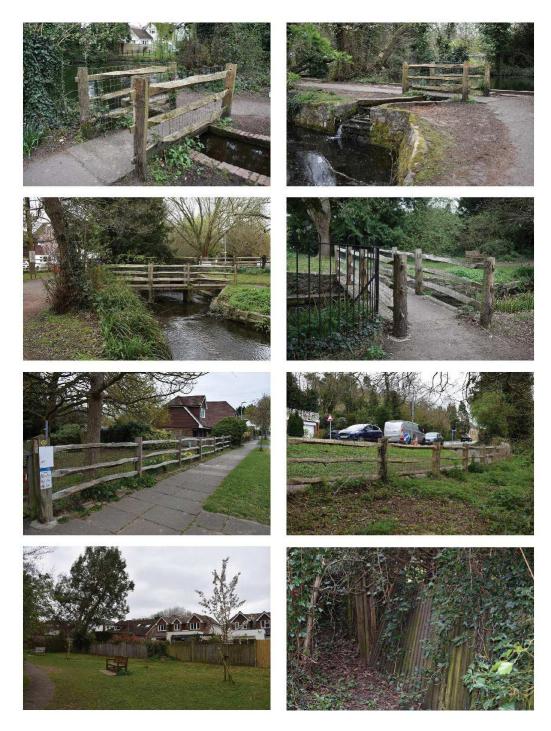
Plate 10: Bridges and Boundaries

The majority of the outer boundaries are defined by tall, close board timber fencing, which has a domestic garden character and varies in condition and appearance throughout the landscape (Plate 10.7). Some sections of the timber fencing have trellis panels along the top and several garden gates, of various sizes and styles, were observed to have been fitted within the fencing, enabling adjacent residents access into the park. Timber fencing along the eastern boundary of the North Park, was observed to be in poor structural condition, with heavy ivy growth pulling the fence panels over (Plate 10.8).

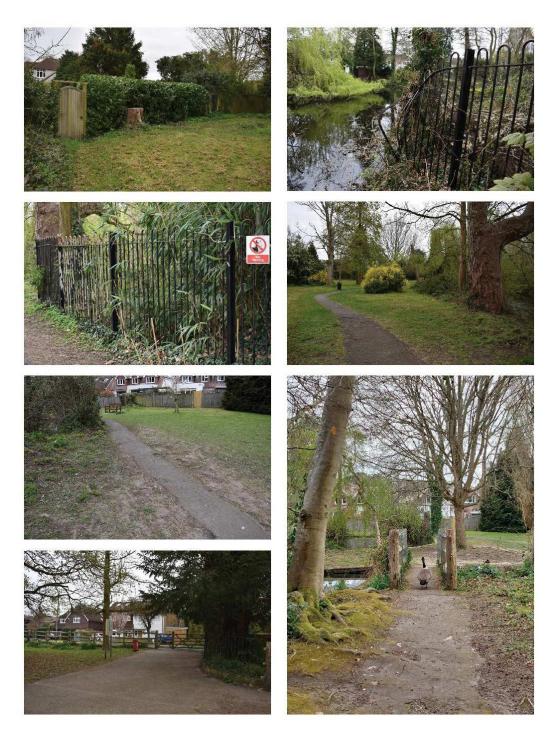
Plate 11: Boundaries and paths

Informal Paths and Desire Lines - Desire lines were noted during the site assessment visit and are largely concentrated in areas where visitors congregate, such as around Lake 4 and the shallow stream to the south of Lake 5. These lines are created perhaps as visitors are unable to find circular routes and wish to explore further into the landscape. One path that has been created is to the south west of the shallow stream in the North Park, where the hard surfaced path leads visitors across a bridge but terminates at a wooden bench. A desire line extends from the bench into the adjacent woodland and to a point where the streamside ragstone retaining wall has been damaged and an earth path has been created into the water (Plate 12.1).

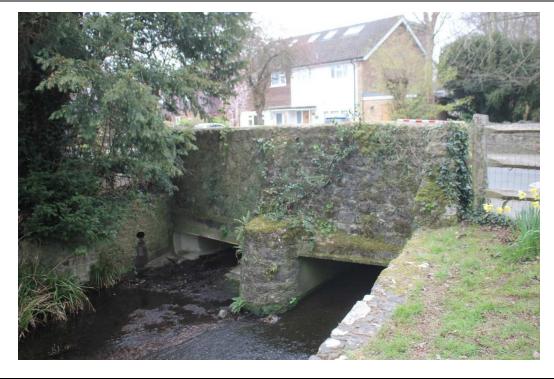
Site No: 1	Name: Bettenson Avenue
Dimensions: length 6m, height is 3.5m from surface of	NGR: 551835, 156201
water	
Date first depicted: 1909-1938 but possibly 1769	HER no
Type: Bridge	Photos: B1.1 to B1.4

A bridge constructed across Bettenson Avenue, and is of the full width of Bettenson Avenue, and accordingly is quite wide. It is of stone construction with sub circular break waters and a later buttress supporting a parapet wall extending from the cut water, and which may have been subsequently added or repaired. It has similar construction techniques on either side of the road, so it would appear to relate directly to the construction of Bettenson Avenue. It has been relined with concrete and there are two channels on either side of the cut water. That to the west has a higher cement lined ceiling than that to the east. It is linked into the stone stream walling. The length of the bridge has been seemingly extended; the break water is not in the centre of the channel and the masonry above the western channel is different from that to the east. Bettenson Avenue was constructed between 1909 and 1938 according to OS maps and the bridge is presumed to be of the same date. It is clearly a modified structure from its early 20<sup>th</sup> century origins, but there was a bridge depicted on the 1833 sale map in approximately this location for an earlier road, and indeed the maps of 1801 and 1769 show a bridge in this location enabling the passage of the stream under the turnpike road, which was shown as being in the general location of Bettenson Avenue. As such there may be elements of the bridge that date back to the eighteenth century.

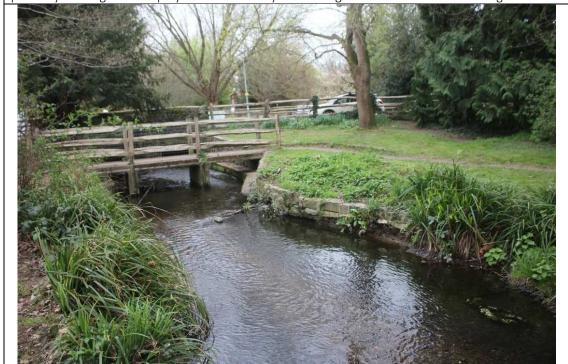
Site No: 2	Name: Lake 5
Dimensions: length c 19m	NGR: 552058, 156245
Date first depicted: Twentieth century	HER no

The stream wall that extends on the western side of the stream that extends between the main stream channel and Lake 5. It is roughly constructed incorporating roughly dressed masonry with thick cementitious mortar joints. There is concrete edging constructed against the masonry edges. In places the masonry is undercut, showing it to be constructed on un-founded soil deposits. There is a distinct choke or narrowing of the stream constraint introduced after a modern wooden and concrete bridge, and the implication is that the narrowing of the channel is related to the construction of the bridge. Part of the Wall is supported by concrete. The wall construction is probably not of great antiquity and is essentially formalising an older earthen stream edge.

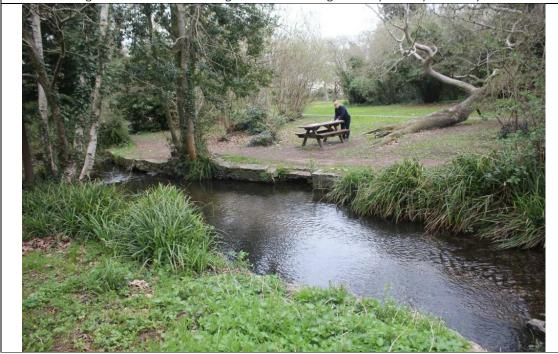
Site No: 3	Name: Lake 5
Dimensions: length c 76m	NGR: 552045, 156272
Date first depicted: Twentieth century	HER no
Type: Stream revetment wall	Photos: B3.1 to B3.2

A stone constructed channel wall incorporating lime mortar with dressed mortar. It continues around the south eastern part of the lake. It has a different build, with more dressed masonry than its counterpart of the west side of the stream. It narrows as it extends up to the small island (Site 5). There is a couple of steps (Site 4) extending through this earth retaining wall to gain access to the stream edge. It reflects a formalising of the stream edge and is probably relatively recent.

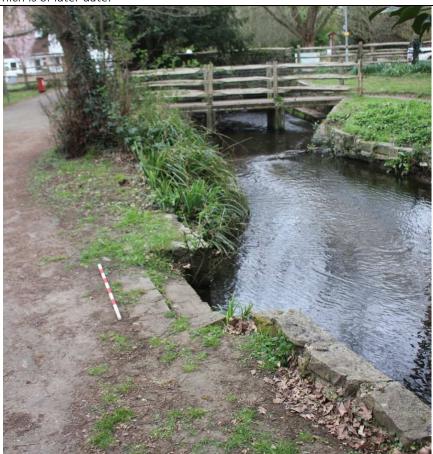
Site No: 4	Name: Lake 5
Dimensions: length c 76m	NGR: 552061, 156252
Date first depicted: Twentieth century	HER no
Type: Steps	Photos: B4.1 to B4.2

A set of stone steps set through wall 3. It has two steps and is constructed of dressed masonry. It is 1.3m in width and 0.35m in observable depth. It is probably contemporary with the construction of the wall, which is of later date.

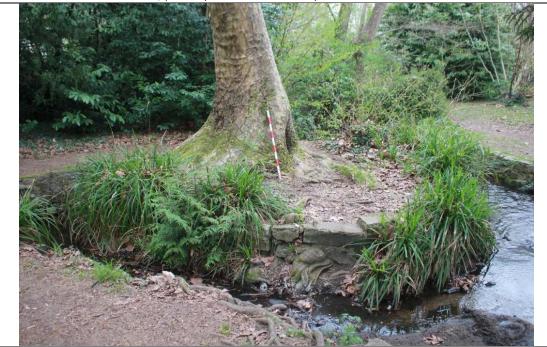
Site No: 5	Name: Lake 5
Dimensions: 5.9m x 4.6m	NGR: 552059, 156225
Date first depicted: 1966	HER no
Type: Island within stream	Photos: B5.1 to B5.4

A small island with a plane tree in the middle. It has a stone revetment around it and there are two channels leading around it from culvert 6. The island may have been intended to protect the tree when the culvert was put in. The outer wall is roughly constructed and is undermined by the roots of the plane tree. It is to be presumed that the retaining wall postdates the tree, and its formation was intended to allow the outfall from the culvert (Site 6) and to protect the tree. The conclusion can be drawn that the construction of the culverts and the island were part of pleasure grounds. As a feature it is first shown on the 1966 1:2500 map, but the tree is much older and it is possible that the island has an earlier, possibly nineteenth century date.

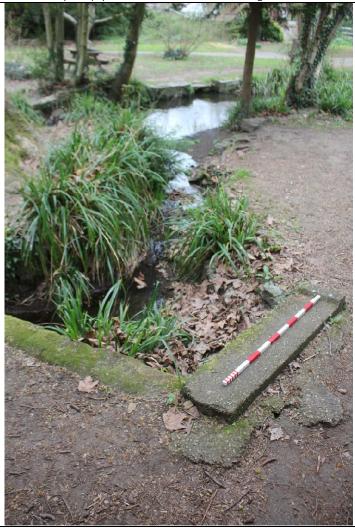
Site No: 6	Name: Lake 5
Dimensions: Width 1.6m	NGR: 552046, 156253
Date first depicted: 1871 1st edition map	HER no
Type: Culvert outfall	Photos: B6.1 to B6.3

A culvert outfall leading from a buried culvert that extends to the west. It is now blocked and has a concrete cap but was stone constructed. A foot path extends over the outfall of the culvert and there are two stone faced channels extending east from the outfall on either side of island (Site 5). These channels are 0.3m across and so was not intended for a large flow of traffic. The channel to the west is shown on 1871 6" mapping and the 1879-85 25" mapping as being an east/west broad channel which extends towards the main stream channel at this point. This east/west channel is depicted as extremely broad and may have been linear lakes that were part of the pleasure ground associated with Bradbourne house, and does not correspond with the very narrow underground outfall, in which case this may simply be a run off conduit leading into the main channel.

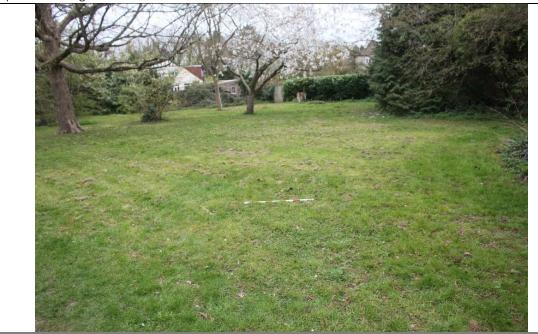
Site No: 7	Name: Bradbourne Lake 5
Dimensions: unknown	NGR: 552067, 156288
Date first depicted: 1801	HER no
Type: Site of Building	Photos: B.1 to B7.2

The site of building shown on the 1801 map which is located immediately upslope and to the east from what is believed was a mill pond. It is shown as an east/west orientated building on the tithe map (1840) and on the 1833 sale map. By 1868 (OS 6" map) the area had been turned over as part of the pleasure ground with regularly planted trees, and Lake 5 had been reformed from the mill pond. Nothing is now visible.

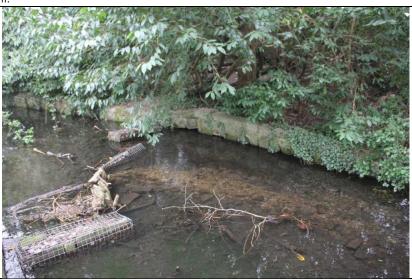
Site No: 8	Name: Bradbourne Lake 5
Dimensions: Length 27m	NGR: 552067, 156288
Date first depicted: 20 <sup>th</sup> century	HER no
Type: Revetment wall for stream	Photos: B8.1

A stone stream wall leading to Lake 5, which incorporates multiple types of masonry and may reflect that it has been subject to multiple repairs and modifications. It extends out from the Site 6 culvert outfall.

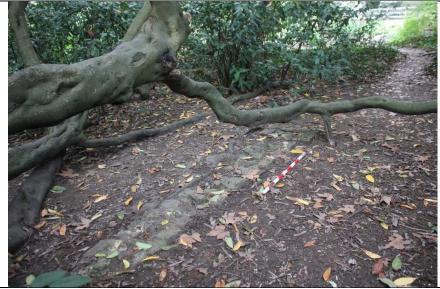
Site No: 9	Name: Bradbourne Lake 5
Dimensions: Length 27m	NGR: 552047, 156264
Date first depicted: 1871	HER no
Type: Garden Wall	Photos: B9.1 to B9.3

A garden wall surviving only as a low foundation with an aperture for gate and which includes a hinge socket on its southern side. It is constructed of crudely dressed masonry and is orientated north north west / south south east parallel to the line of the main stream. It appears to be on the 6'' 1st edition map (1871) but not on the tithe map, and had gone by the time of the 1945 1:2500 map.

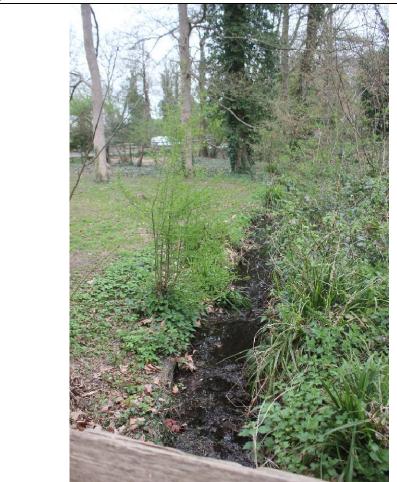
Site No: 10	Name: Bradbourne Lake 5
Dimensions: Length 48.3m	NGR: 552046, 156361
Date first depicted: 1897	HER no
Type: Open Culvert	Photos: B10.1 to B10.2

An open culvert extending east and which is stone faced in places. It extends north east/ south west from Lake 5, where there is an annotation of "SL" (sluice) on the 1909 map. On the latter map it is shown as straight, but now has a distinct curve which may reflect that the line of the overflow channel has migrated slightly. It is not shown on the 1879 mapping but is shown on the 1897 mapping.

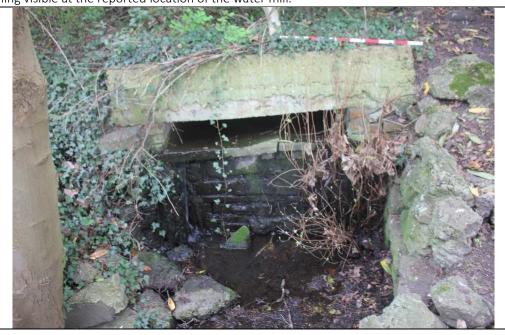
Site No: 11	Name: Bradbourne Lake 5
Dimensions: Length 5m x 2.6m	NGR: 551984, 156360
Date first depicted: 1801	HER no
Type: Outfall for Lake 5	Photos: B11.1 to B11.6

This is the original outfall for Lake 5, and the putative mill pond that preceded it. It has stone sides and a concrete cap supported by bricks. It has a raised platform leading to a 1m high level above the base of the channel, and this height difference is probably the reason for a reference to a waterfall on the 1909 25" map; on the same map is a very small structure adjacent to the outfall. The raised level of the outfall would have controlled the level of water in the lake, but could potentially have provided a height gradient for a water wheel. The wall extends directly out of it, but is broken to create a divergent side channel leading to the main channel (Site 15). In the original line of the channel there is an artificially raised embankment which could have supported the line of a leat at a raised level sufficient to have provided power further down the line. There is a substantial number of modifications visible in the outfall for the lake and may be an indication that it has had an extended active life.

From the OS 1<sup>st</sup> edition map of 1871, there are two channels leading out from the dam forming the northwest side of the lake. That on the eastern side extends to a primary stream that was the original line of the beck, the one to the west extending from this outfall extends up to the present road, and then runs along it for c110m and then crosses it, where there is a sluice before following a straight line channel for 300m, via a sluice, and then diverts again back to the main stream channel. This deliberate diversion of water flow would make sense as a mechanism for providing water for a mill, with the main eastern channel serving as an over flow channel. While this is a potential cause of the hydraulic diversion there is no mill labelled on any of the nineteenth century plans and no structures that could correspond to a mill on the line of the dog legged channel. The alternative is that these channels are a survival of a mill that was formerly in this location, but which is no longer in use. If that is the case the most likely locations are at the outfall of the lake (Site 11) where there is a channel deep enough to be a wheel pit, or at the location of the sluice marked on the 1897 25" map.

The location of the water mill is defined on the HER (No. MKE116484), but the depicted location is removed from the site of the original channel from the millpond and is probably false. There is nothing visible at the reported location of the water mill.

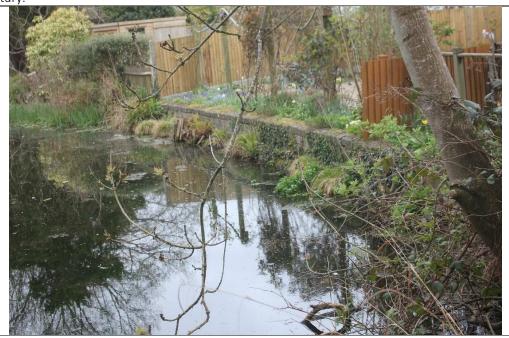
Site No: 12	Name: Bradbourne Lake 5
Dimensions: Length 56m	NGR: 551987, 156331
Date first depicted: 20 <sup>th</sup> century	HER no
Type: Revetment Wall	Photos: B12.1 to B12.2

A lake wall incorporating dressed stones extending around the western side of the lake. The gardens of the houses to the west extend up to this wall and the wall will have provided the boundary between the gardens and lake. The wall does not look particularly old and was probably repaired or constructed when the houses were established prior to the 1946 25" map. The lake dates to 1801, but the wall will be a later insertion to define the lake edge, probably in the 20<sup>th</sup> century.

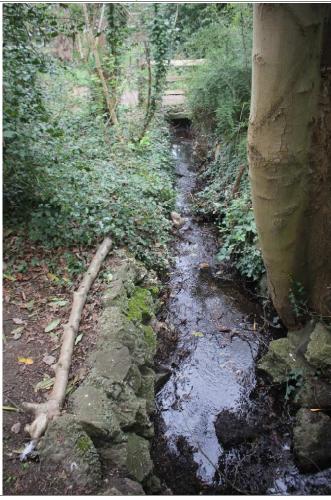
Site No: 13	Name: Bradbourne Lake 5
Dimensions: Length 17m	NGR: 551986, 156370
Date first depicted: 1966	HER no
Type: Cross feed between two outfalls of	Photos: B13.1
Lake 5

A later channel between the western outfall (Site 11) and the main channel (site 15). It is very crudely constructed with irregular undressed field stones loosely bonded with modern mortar. It follows a straight course and extends under a recent concrete bridge and feeds into the modern concrete outfall for Lake 5 (Site 15). It is not depicted on the 1946 6" map, but this map only shows one channel (Site 15), and it must have been in place to divert the flow from the western outfall (Site 11). It is shown on the 1966 1:2500 map.

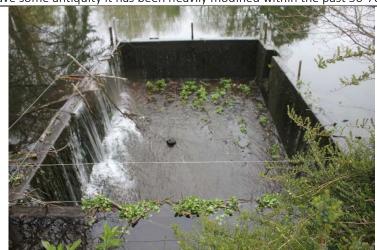
Site No: 15	Name: Bradbourne Lake 5
Dimensions: Length 40m	NGR: 551996, 156376
Date first depicted: 1871	HER no
Type: Secondary outfall from Lake 5	Photos: B15.1-B15.7

This is presently the main stream channel and outfall from Lake 5, but was originally an overflow channel. It has a rectangular catchment pond within the lake to capture the flow and control the level of the lake, and this leads to a concrete constructed channel that leads under the footpath. It is generally of modern concrete construction, but the channel has some stone edging and some concrete edging and also in places just an earthen bank it leads from the dam to the modern road. It is shown on the first edition 6" OS map (1871) and possibly also the 1833 sale map. The channel beneath the modern A25 road is a substantial concrete bridge which was intended to take heavy vehicle loads. It has a side ceramic drain set into the concrete structure. While the line of the channel may have some antiquity it has been heavily modified within the past 50-70 years.

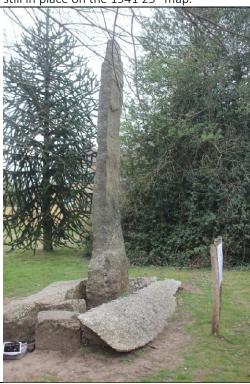
Site No: 16	Name: Betenson Avenue
Dimensions: 4m x 3m	NGR: 552057, 156214
Date first depicted: 1897 (in original	HER no: MKE115070 – TQ 55 NW 582
location)	Locally Listed Building 10791
Type: Monolith from Stone Circle Folly	Photos: B16.1-B16.2

This is the re located monolith from a late 19th century folly. The original was located to the south west of Bradbourne Hall and was part of a stone circle with eight stones. It was shown in situ on the 1897 25" map and was still in place on the 1941 25" map.

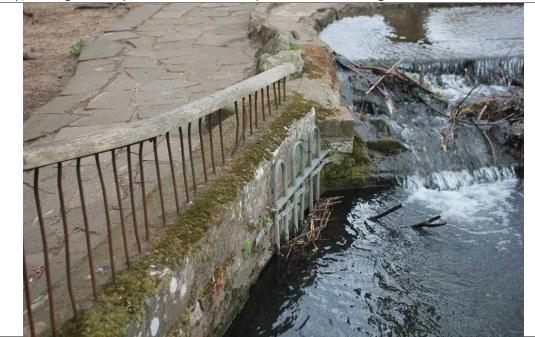
Site No: 18	Name: Bradbourne Lake 4
Dimensions: 14.5m	NGR: 552078, 156184
Date first depicted: 1833	HER no:
Type: Culvert	Photos: B18.1-B18.3

An underground channel that extends from an outfall of Lake 4 into the side stream culvert. It has a grill over the entrance and feeds from a stone and concrete pond that is part of the lake 4 outfall. It is an integral and presumably original of the complex outfall arrangement from Lake 4, and was probably a part of the original outfall arrangement of Lake 4 which was first depicted on the 1833 map, although this may have been substantially modified from its original form.

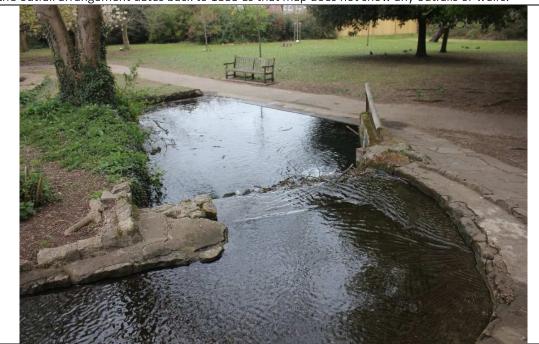
Site No: 19	Name: Bradbourne Lake 4
Dimensions: 12.0m x 8.9m	NGR: 552076, 156175
Date first depicted: 1871	HER no:
Type: Culvert	Photos: B19.1-B19.5

An outfall weir feeds out from lake 4 down a ramp into a small rectangular pond. It controls the level of the pond and provides a controlled release of water to the stream. The level of the weir controls the level of the water in Lake 4 and there is a drop to a holding pond which then feeds through a culvert into the main side stream. The outfall has a distinctive shape and is evident on the 1871 OS map which is after the pond was landscaped subsequent to the 1840 tithe map; it is possible that the outfall arrangement dates back to 1833 as that map does not show any outfalls or weirs.

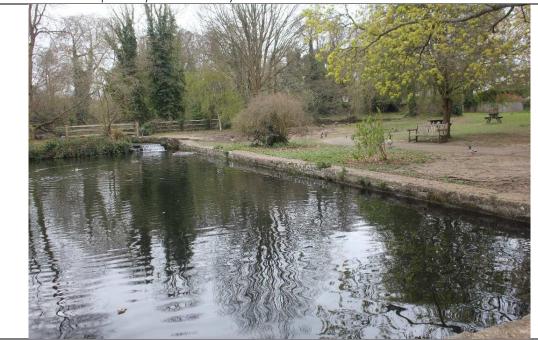
Site No: 20	Name: Bradbourne Lake 4
Dimensions: length 52m	NGR: 552063, 156148
Date first depicted: 20 <sup>th</sup> century	HER no:
Type: Lake 4 revetment wall	Photos: B20.1-B20.2

This is the stone-faced wall of Lake 4 which has dressed stone and mortar, and extends between the Site 19 weir and the Site 21 outfall; it posts dates Site 21 weir. The revetment wall is a later element of the lake and is probably of 20<sup>th</sup> century date.

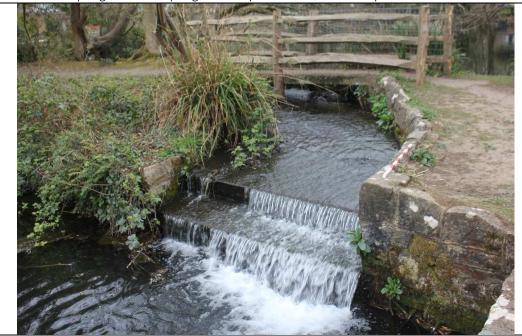
Site No: 21	Name: Bradbourne Lakes 3 / 4
Dimensions: length 8.2m width 2.6m	NGR: 552069, 156130
Date first depicted: 1871	HER no:
Type: Outfall Lake 3 to 4	Photos: B21.1-B21.2

A two-stage step weir outfall from Lake 3 to Lake 4, and which defines the water level in Lake 3; there is a drop of c 70cm between that of Lake 3 and Lake 4. There is a lip at the southern part of Lake 3 and then a level (pool) area before a further drop into Lake 4. There is a steady flow through it, and it is constructed of rough dressed stone. The outer facing wall (Site 20) butts up against the weir walling. There is a weir shown in this location on the OS first edition 6'' (1871) and the 25'' (1879-85) maps. Both maps show a spring immediately to the west of the outfall feeding into Lake 4. This has been blocked by the construction of the lake wall (Site 20) and there is no longer any indication of a spring here. The spring is not depicted on the 1897 map.

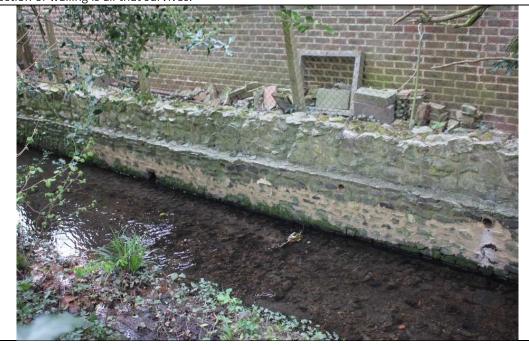
Site No: 22	Name: Bradbourne Park
Dimensions: length 12.4m	NGR: 552142, 156142
Date first depicted: 1833	HER no:
Type: Building	Photos: B22.1-B22.3

This comprises a wall constructed on top of the main easterly stream wall. It is a surviving component of an unnamed building shown on the 1833 sale map but seemingly not on the 1801 1" to 1 mile map. This would indicate that the stream channel predates the 1833 sale map, and the building postdates the stream. It is clearly shown on the 1871 6" map and by 1897 was a sizeable domestic complex. It is still shown on the 1950 6 "mapping even though there has been considerable expansion of estates around the lakes. The building no longer survives, and this section of walling is all that survives.

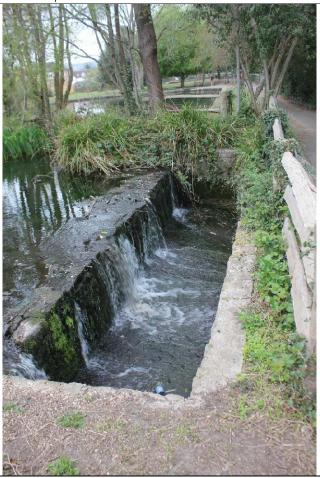
Site No: 23	Name: Bradbourne Lake 3
Dimensions: length 7.8m width 2.5m	NGR: 552100, 156123
Date first depicted: 1833	HER no:
Type: Weir / Lake Outfall	Photos: B23.1-B23.3

This is an outfall from Lake 3 comprising a weir with a 1.3m drop that leads into a culvert beneath the path to lead into the main stream (Site 24). The large Lake 3 also has an outfall (Site 21) into Lake 4, but this outfall leads to the divert stream. This would have provided the overflow channel in times of flood to bypass the flow through Lake 4 and accordingly it is capable of taking considerable flow as is also the bypass stream channel (Site 24). At present there is a comparable flow through both weirs 23 and 21 which would indicate that both are set at the same level. The weir is well constructed in stone and is the bypass main channel leading from Lake 3. It is constructed of poorly dressed masonry with cement mortar and drops down onto a concrete ramp to flow into the channel which extends under a stone constructed bridge supporting the foot path. The channel diverts directly into the main divert stream channel (Site 24). There is seemingly a divert stream channel on the 1833 sale map, but the first definitive indicator of a weir from this point of Lake 3 is on the 1871 first edition 6" map.

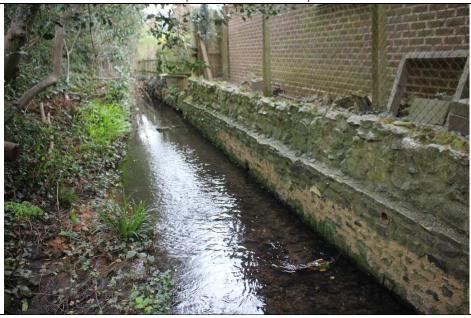
Site No: 24	Name: Bradbourne Lakes 3 and 4
Dimensions: length 171m to Lake 5	NGR: 552090, 156179
Date first depicted: 1801	HER no:
Type: Stream channel	Photos: B24.1-B24.6

This is the main stream channel which is fed from the 23 outfalls. The channel has deep sides constructed of rough mortar bonded masonry. There is also a subterranean channel feeding into it which leads in from the south; however, there is only a very limited flow coming through this subterranean channel, but may have had a greater flow in the past or is a further flood bypass channel from Lake 1.

The channel dates back to at least the 1833 sale map which shows the line of a stream adjacent to the series of lakes. The 1801 1" to 1 mile map is fairly schematic but does show a stream that extends from a spring located somewhere in the area of Lake 1, although at this stage there were no lakes. Given that the lakes were subsequently established it is not possible to determine if the stream was in the current position or further to the west on the basis of this somewhat schematic mapping. Interestingly the 1769 map of the area shows that the stream channel extended further to the south and was not supplied by a spring. This raises the possibility that there has always been a stream channel from the south, but which was canalised and turned into a subterranean channel between 1769 and 1801 and as such reflects some hydrological modification.

The main stone-faced stream channel that extends along the eastern side of the four lakes now incorporates cement mortar (having been repointed) with poorly dressed field stones. The channel is also shown on the 1871 6" to 1 mil map and on the 1833 map.

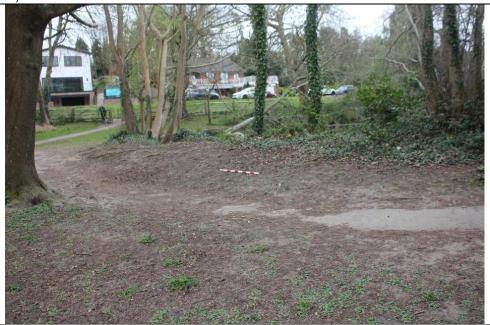
Site No: 25	Name: Bradbourne Lake 1
Dimensions: length 23.9m width 3.1m	NGR: 552118, 156083
Date first depicted: 1871	HER no:
Type: Northern edge of Lake 1 defined by	Photos: B25.1
earthen bund

There is a large earthen bund forming the north side of lake 1 and is evidently an artificial feature. It is slightly irregular but is not a recent feature as there are substantial trees growing from it and the make up of the bund is now dominated by roots. It was presumably a mechanism to prevent overflow of the lake in times of flood. It is not a feature that shows up on historic mapping, but probably was put in place when Lake 1 was contracted from its former extended shape form to its present form between the 1833 and 1871 maps. It is probable that there was formerly a channel extending between Lake 1 at this location towards the main stream channel (Site 24), but there is presently no indication of one.

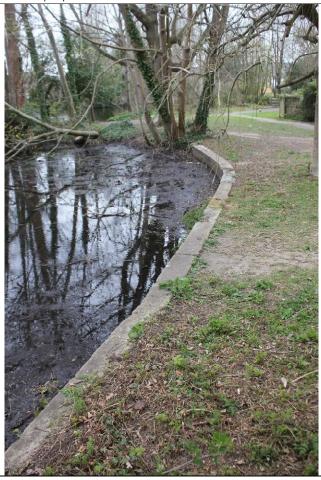
Site No: 26	Name: Bradbourne Lake 1
Dimensions: length 17.2m	NGR: 552136, 156078
Date first depicted: Twentieth century	HER no:
Type: Northern eastern edge of Lake 1	Photos: B26.1
defined by a stone revetment wall

A section of stone wall edging Lake 1 at its north east perimeter. It incorporates well dressed masonry, almost ashlar and contrasts with the rougher constructed lake walling seen elsewhere. It is probably not of great antiquity.

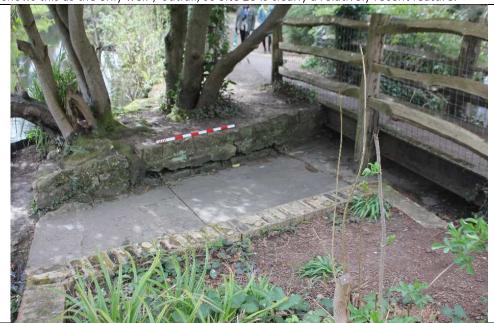
Site No: 27	Name: Bradbourne Lakes 1 and 3
Dimensions: length 6.5m x 2.8m	NGR: 552104, 156076
Date first depicted: 1871	HER no:
Type: weir between Lakes 1 and 3	Photos: B27.1

A stone constructed weir incorporating poorly dressed stone and some field stones. This is off set by a modern low brick wall, which has narrowed the aperture of the weir / outfall. It feeds under an 'I' beam constructed bridge and leads to a series of steps into Lake 3. It is higher than outfall 28 and is now dry and is presumably a high-level overflow. This is the weir / outflow shown on the 1871 first edition 6" map; that further to the west (Site 28) was not shown. Similarly, the 1941 OS 1:2500 map shows this as the only weir / outfall, so Site 28 is clearly a relatively recent feature.

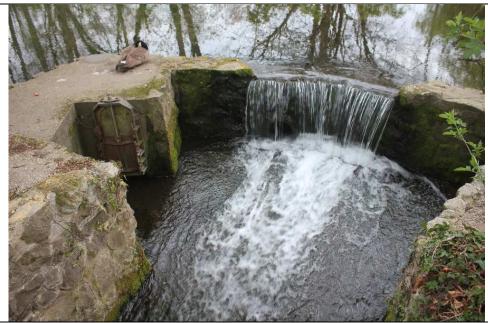
Site No: 28	Name: Bradbourne Lakes 1 and 3
Dimensions: length 12.4m x 4.1m	NGR: 552085, 156066
Date first depicted: later 20 <sup>th</sup> century	HER no:
Type: weir between Lakes 1 and 3	Photos: B28.1to B28.4

A stone constructed overflow with controlled weir level to define the level for lake 1. There is a blocked pipe at the base of the weir and a now redundant gate mechanism to the west having a concrete block inserted to the east. It was not in place in 1941 and is a later 20<sup>th</sup> century modification to control the outfall from Lake 1.

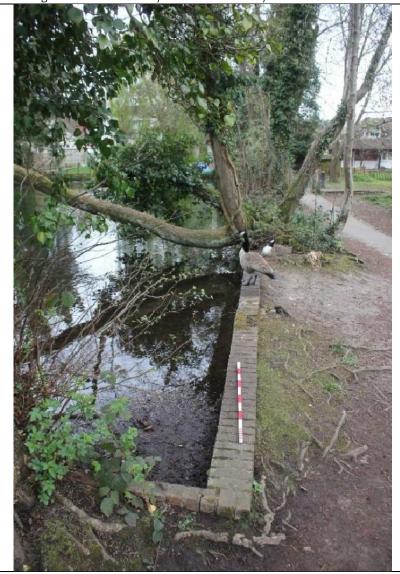
Site No: 29	Name: Bradbourne Lake 2
Dimensions: length 72m	NGR: 552046, 156084
Date first depicted: 1833	HER no:
Type: revetment wall of Lake 2	Photos: B29.1to B29.2

The Lake 2 brick constructed outer wall. It is relatively high by comparison with Lake 3 to the north. The use of mainly brick would suggest it is a later construction. However, the outline of the lake matches that on the 1833 mapping, and it may not have been significantly changed in outline since that date (even though the outer wall may have been rebuilt).

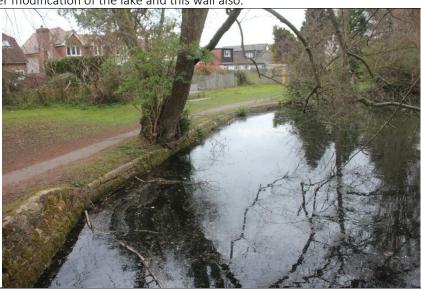
Site No: 31	Name: Bradbourne Lake 3
Dimensions: length 60m	NGR: 552074, 156087
Date first depicted: 1871	HER no:
Type: revetment wall of Lake 3	Photos: B31.1

A brick topped stone structure or entirely brick wall around the perimeter of the western part of lake 3. The western part of the lake had a constricted outline in 1871 by comparison with that shown on the tithe map (1840) and the 1833 sale map and it is possible this western edge of the lake is a later modification of the lake and this wall also.

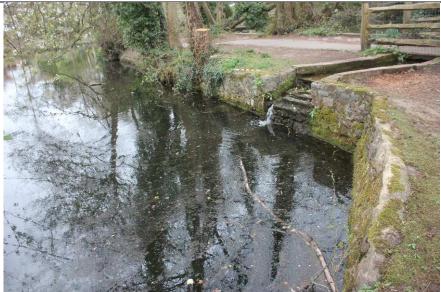
Site No: 32	Name: Bradbourne Lake 3
Dimensions: length 32m	NGR: 552059, 156091
Date first depicted: 1871	HER no:
Type: Revetment wall of Lake 3	Photos: B31.1

The southern part of lake 3 is edged by stone masonry and appears to be older than the section to the west, and which would match up with the cartographic evidence which shows that the western edge was a later line.

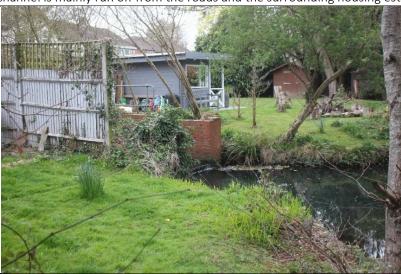
Site No: 35	Name: Bradbourne Lake 1
Dimensions: width 3m	NGR: 552101, 156024
Date first depicted: 1871	HER no:
Type: channel feeding Lake 1	Photos: B35.1 to B35.2

This is the primary inflow to Lake 1, and there is a very limited flow of water from it. This would raise the question where the majority of the water is coming from. The stream inflow channel is shown on the 1st edition OS map (1885) and also on the 1769 map as being the primary stream channel. Interestingly the 1871 OS 1st edition map shows this channel but also two springs immediately to the west of Lake 1. Given that there is very little flow into the Lake from the stream channel, but there is a considerable flow into Lake 3 from Lake 1, it is to be assumed that those two springs are still active and presumably under the present Lake. It is understood that the flow through this channel is mainly run off from the roads and the surrounding housing estate.

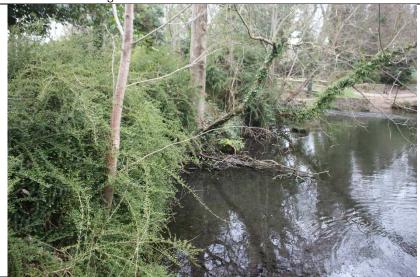
Site No: 36	Name: Bradbourne Lake 3
Dimensions: width 11m	NGR: 552104, 156084
Date first depicted: 1909	HER no:
Type: revetment walling for Lake 3	Photos: B36.1

This is a section of stone walling on the east side of Lake 3.

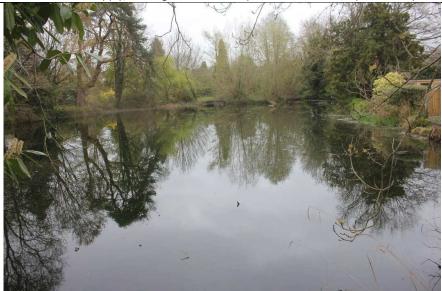
Site No: 42	Name: Bradbourne Lake 5
Dimensions: 83m x 36m	NGR: 552018, 156325
Date: 1801	HER no: MKE115125 (TQ 55 NW 610)
Type: Artificial lake	Photos:

Lake 5 is the earliest of the lakes, and was shown on the 1801 Mudge map, and had at the time a trapezoidal shape, which reflects the construction of a dam but without any specific landscaping of the lake. It had been developed into its present form by the time of the 1833 sales map. The lake had an original weir (Site 11) intended to control the outfall of the lake and also seemingly had an overflow channel (15) feeding into the main stream. The adoption of two outfalls would suggest that from the outset it was intended to provide power or a controlled water supply, although there is no depiction of a mill on any of the maps.

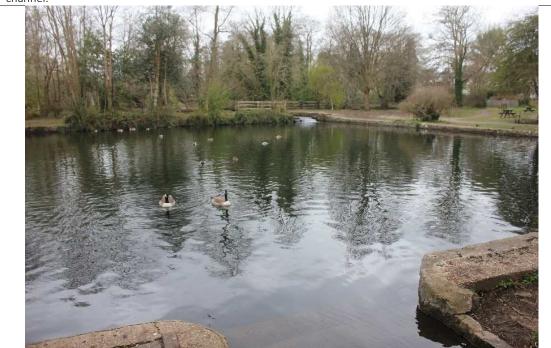
Site No: 43	Name: Bradbourne Lake 4 (Boating Pond)
Dimensions: 37m x 28m	NGR: 552077, 156151
Date: 1833	HER no: MKE115125 (TQ 55 NW 610)
Type: Artificial lake	Photos: B20.1 – B20.2

Lake 4 is one of the four rectangular lakes that had been formed by the time of the 1833 estate map. Their rectangular shape is potentially significant as they would not have been established to serve as part of pleasure grounds, which would have had a more irregular, natural shape conforming to the picturesque movement, emphasising naturalistic and romanticised landscapes. As such these would appear to be more functional, even though they were within an area of parkland. This lake has subsequently been adopted as a boating lake or pond.

It is fed from Lake 3 (Site 21) and then has an outfall via a subterranean culvert (Site 18) into the side stream channel.

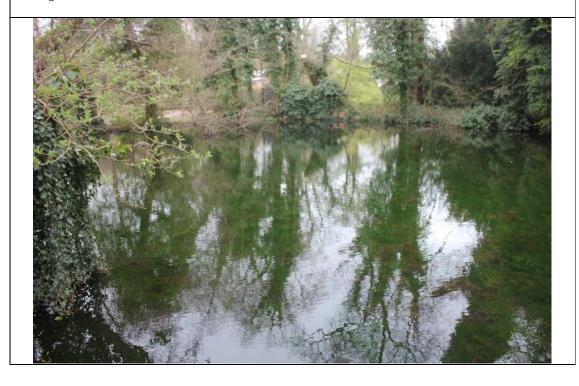
Site No: 44	Name: Bradbourne Lake 3
Dimensions: 67m x 55m	NGR: 552090, 156073
Date: 1833	HER no: MKE115125 (TQ 55 NW 610)
Type: Artificial lake	Photos: Lake 3.2-3.4

Lake 3 is the combination of two of the rectangular lakes that had been formed by the time of the 1833 estate map. Their rectangular shape is potentially significant as they would not have been established to serve as part of pleasure grounds, which would have had a more irregular, natural shape conforming to the picturesque movement, emphasising naturalistic and romanticised landscapes. As such these would appear to be more functional, even though they were within an area of parkland.

Lake 3 was merged from two of the original four rectangular lakes between 1840 and 1871, taking on a more irregular and rounded shape. It is possible that this modification was intended to give it a more naturalistic shape.

The lake is presently fed by three weirs (Sites 27, 28, and 33), there was a further weir (Site 34), but this has been blocked. It has two outfalls, one an over flow weir (Site 23) into the stream channel and one Site 21) feeding into Lake 4.

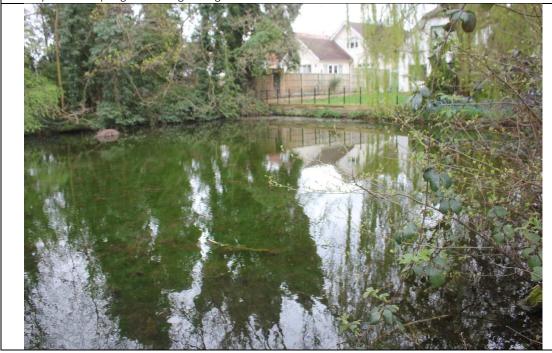
Site No: 45	Name: Bradbourne Lake 2
Dimensions: 67m x 55m	NGR: 552090, 156073
Date: 1833	HER no: MKE115125 (TQ 55 NW 610)
Type: Artificial lake	Photos: Lake 3.2

Lake 2 is one of the four rectangular lakes that had been formed by the time of the 1833 estate map. Their rectangular shape is potentially significant as they would not have been established to serve as part of pleasure grounds, which would have had a more irregular, natural shape conforming to the picturesque movement, emphasising naturalistic and romanticised landscapes. As such these would appear to be more functional, even though they were within an area of parkland.

Lake 2 has not significantly changed in outline since it was first depicted on the 1833 sales map. It is defined by a brick outer wall and is above Lakes 3 and 4, but is separated by an earthen bank / bund from Lake 1. Significantly there is no indication of a feeder channel from Lake 1, and there is no visible evidence of any water flowing into it; yet there is an outflow from the weir (Site 33). This would indicate that the lake is entirely fed from springs extending through the base of the lake.

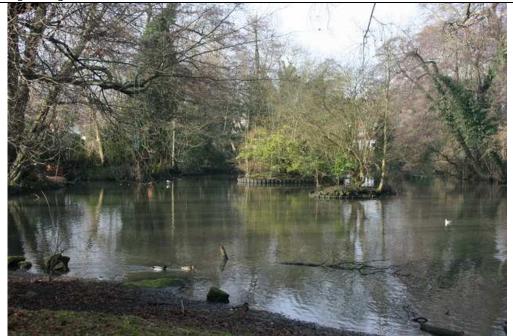
Site No: 46	Name: Bradbourne Lake 1
Dimensions: 109m x 44m	NGR: 552098, 156050
Date: 1833 / 1801	HER no: MKE115125 (TQ 55 NW 610)
Type: Artificial lake	Photos:

Lake 1 is the large lake at the southern part of the lakes group. A spring is shown in the location of this lake on the 1801 map, and may have been a small pond at that time but was not a lake in the form that it subsequently became.

By the time of the 1833 map, it had expanded from a tiny pond into a curved lake which converges at its northern end into the main stream channel (Site 24), and this map shows it at its greatest extent. By the time of the 1971 map the link between the lake and the stream channel had been visually broken, although it's possible that there was a subterranean channel linking them. Its north eastern edge was instead defined by an earthen bund (Site 25) and a retaining wall (Site 26). There is a considerable outflow from this lake into Lake 3, but the inflow channel (Site 35) has almost no flow, and would indicate that the majority of the water entering the lake is from springs feeding through the base of the lake.
